BOW RIVER BACKCHANNEL REHABILITATION

Wim M. Veldman, P.Eng. Manager, Water Resources Group Hardy BBT Limited and Pat Young Fish and Wildlife Division Alberta Forestry, Lands and Wildlife Red Deer

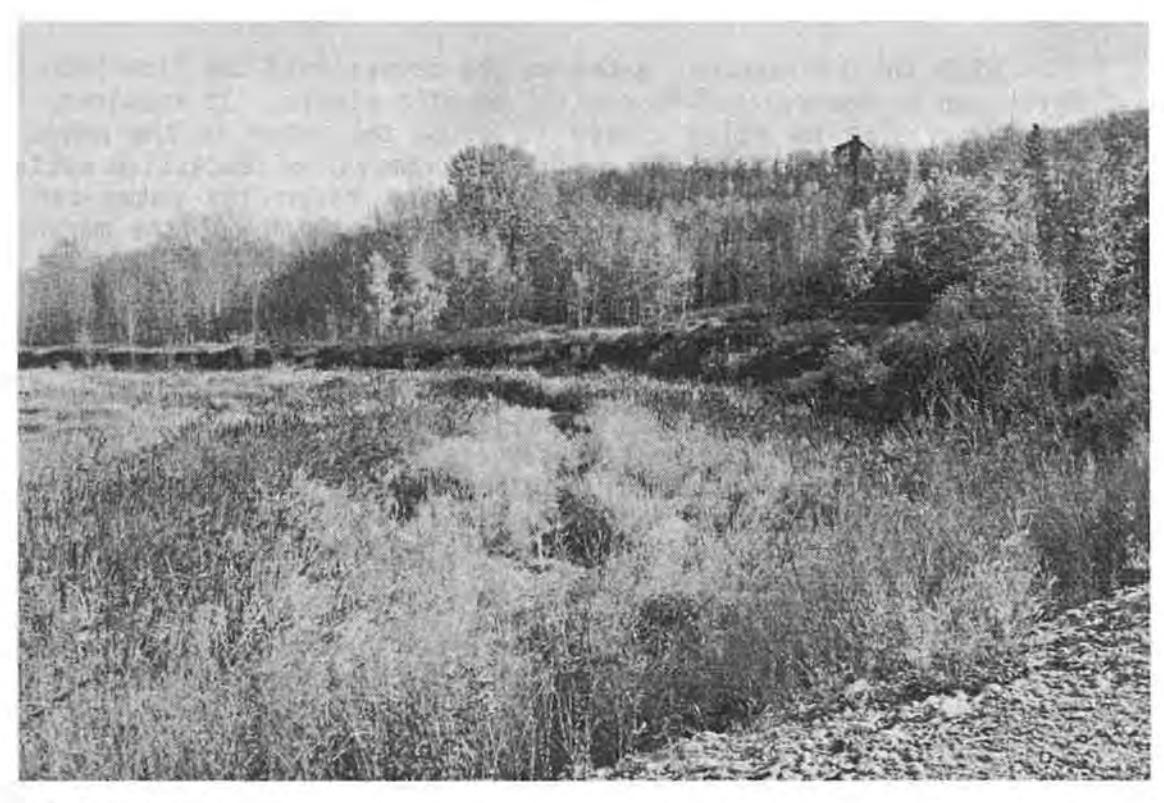
РНОТО 1

Upstream end of the backchannel prior to rehabilitation

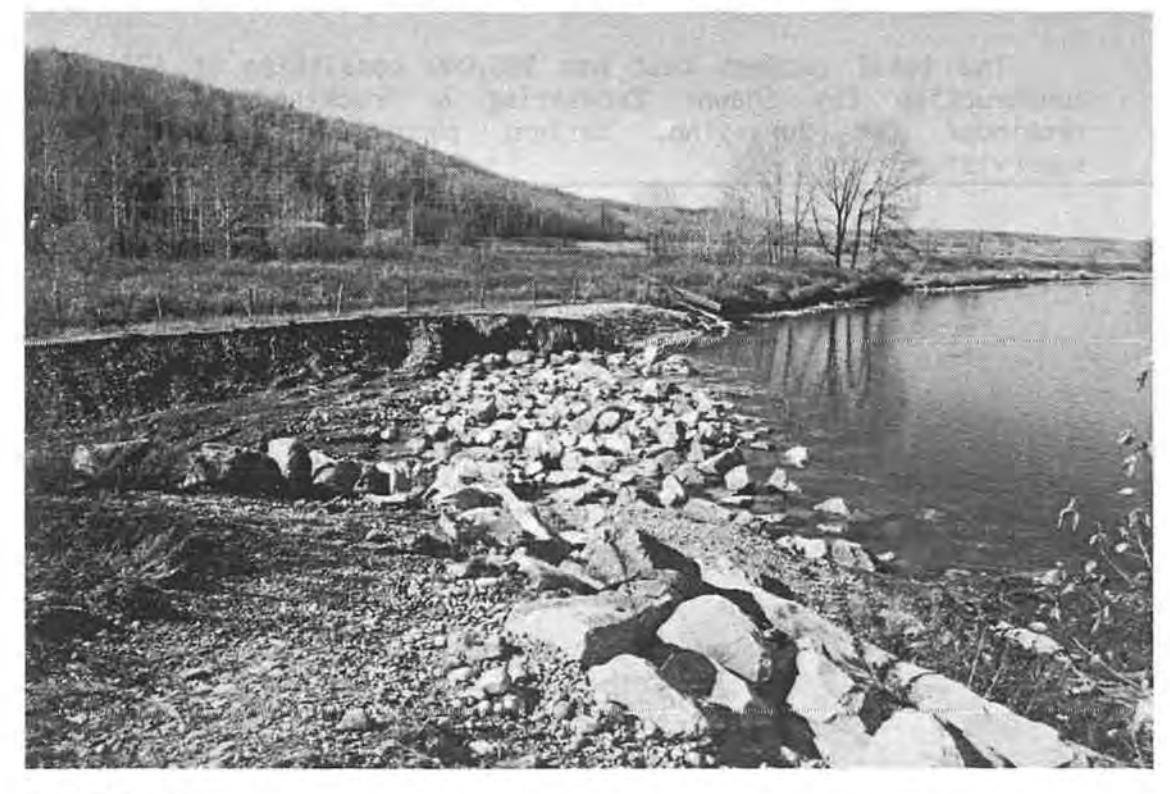
РНОТО 2

Coarse rock layer placed at base of inlet structure - the main infiltration zone. Gabion baskets filled with cobbles complete the structure (see Photo 3).

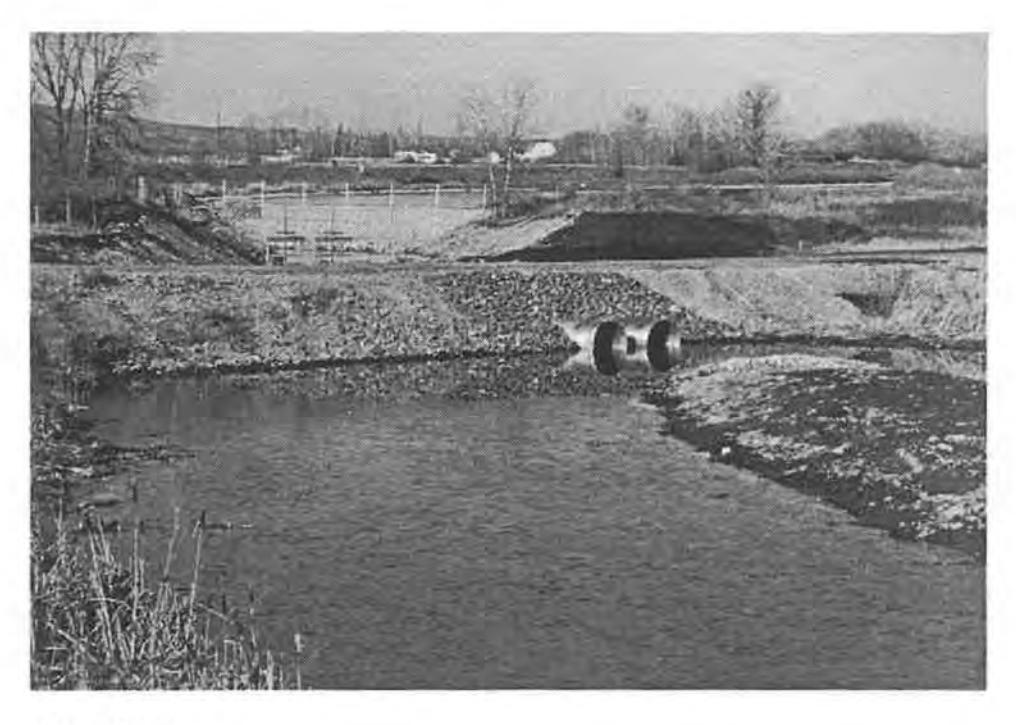
РНОТО 3

Looking upstream at gated culverts and inlet structure at Bow River.

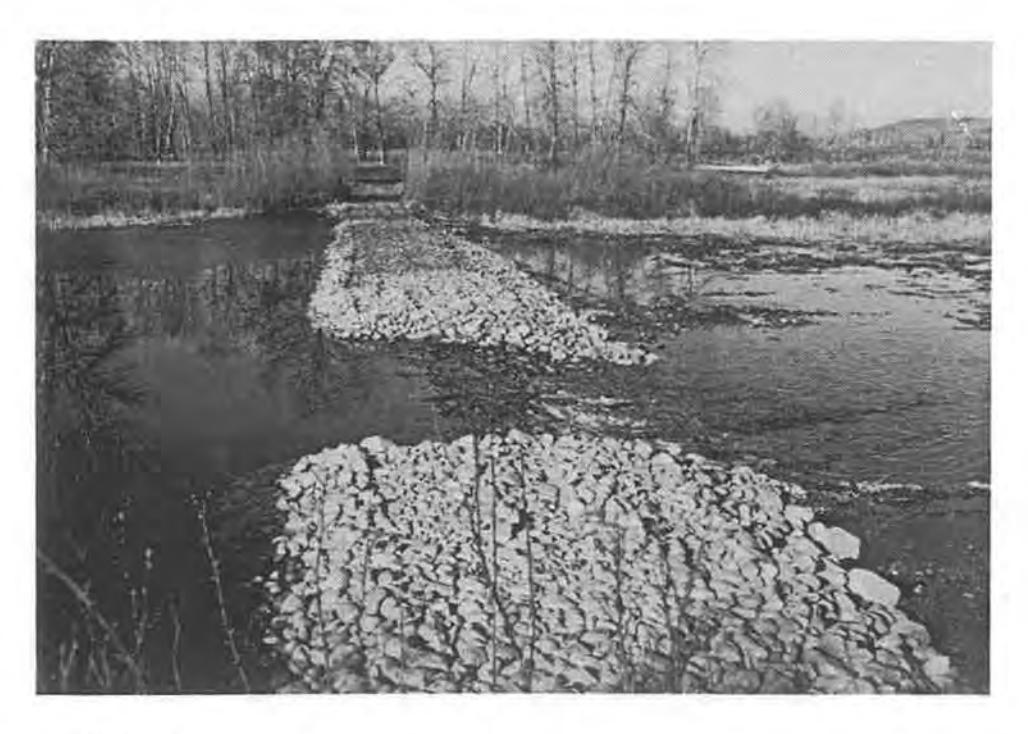
PHOTO 4 Completed rock drop structure under normal flow conditions.

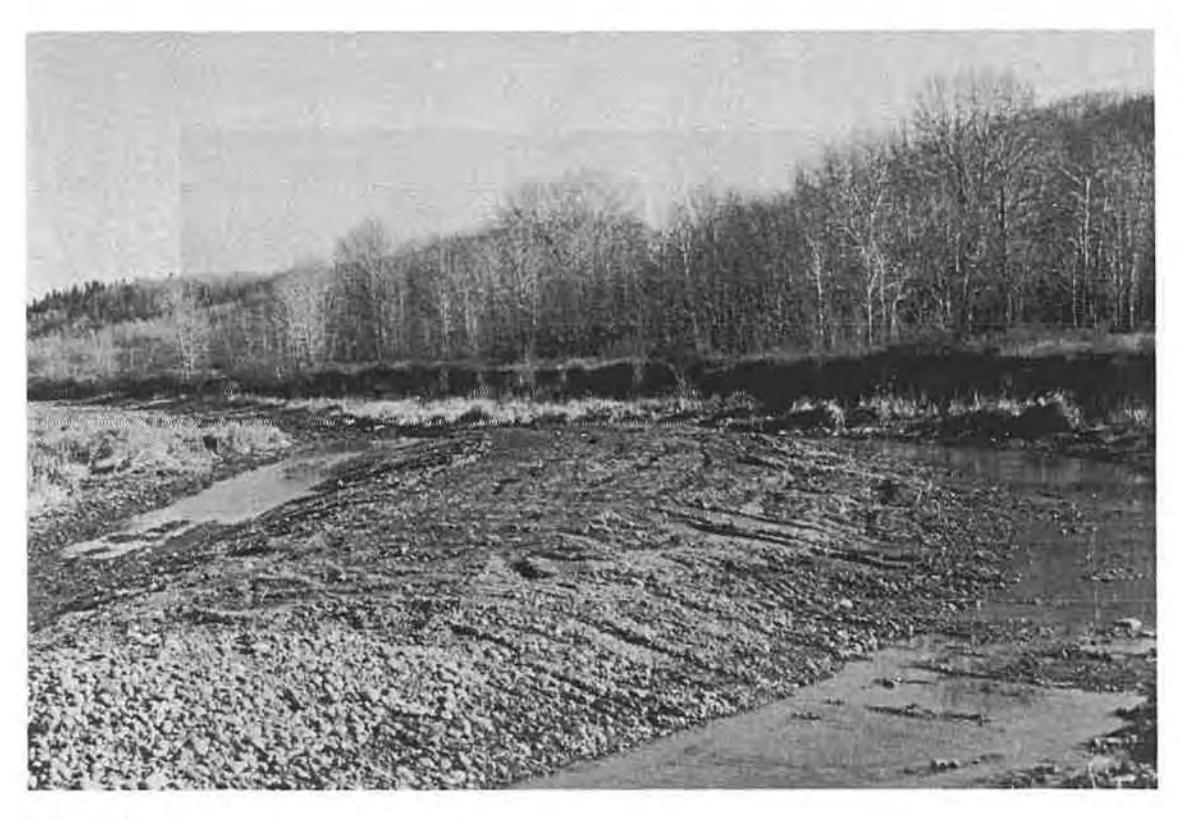
рното 5

Upstream end of backchannel with island during construction.

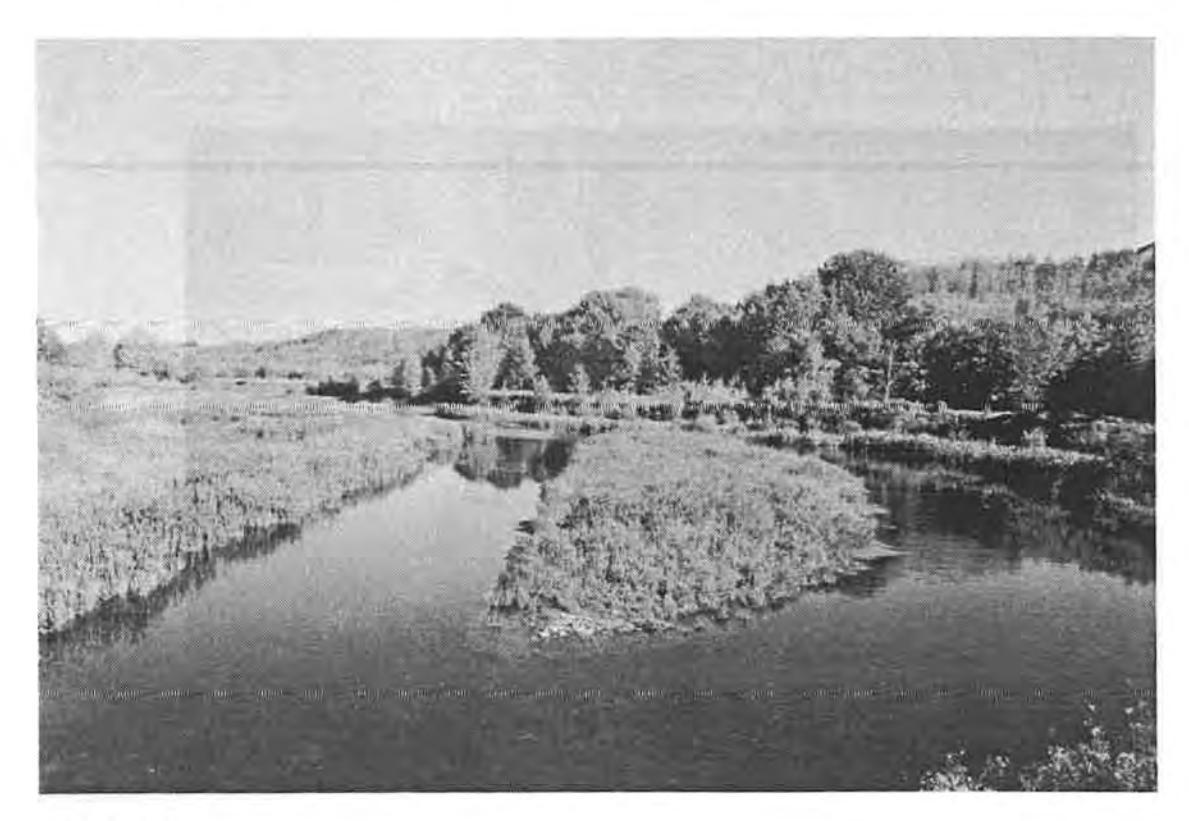
PHOTO 6 Present upstream end of backchannel. Compare to Photo 1.
