A Tale of Two Roads: Consequences of Peat Conditions and Construction Practices on Peatland Effects, Reclaimability, and Best Practice Development

Terry Osko
Circle T Consulting, Inc.

DUC Wetland BMP Workshop, 21 January 2016

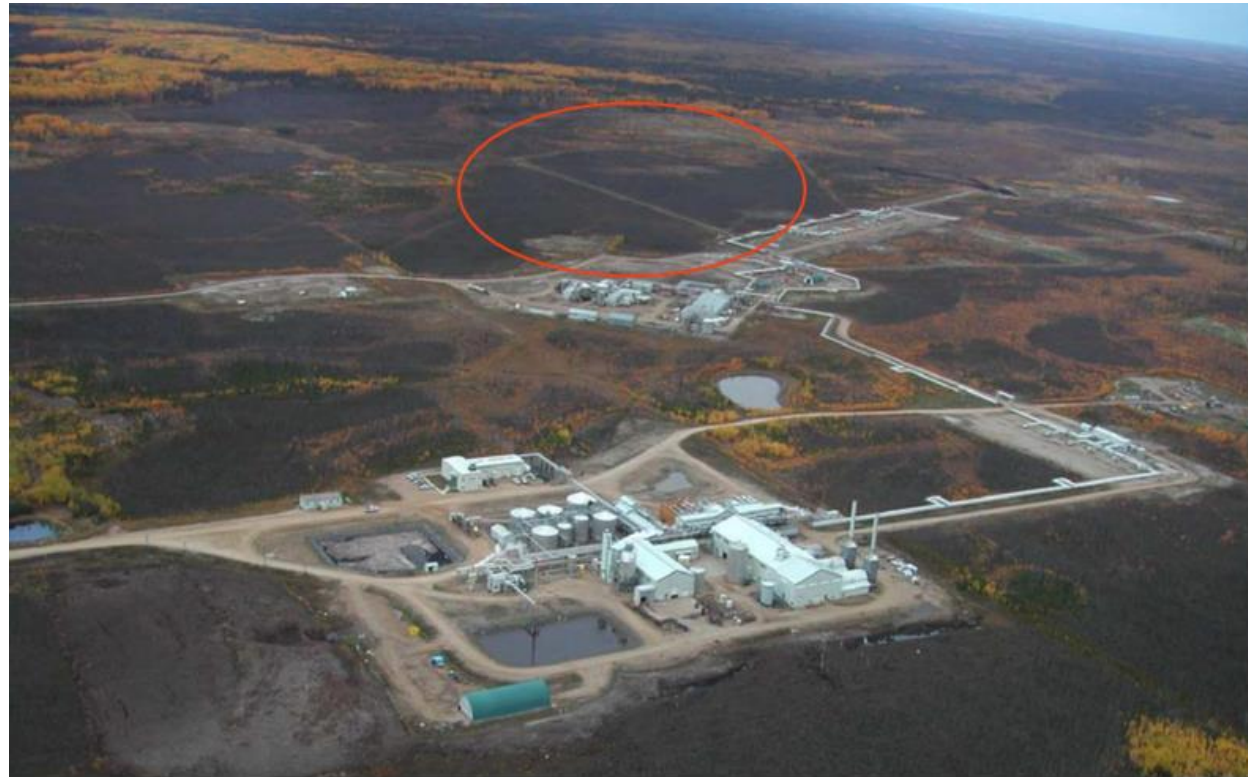
JACOS HANGINGSTONE PROJECT

- Deep peat ☹️
- Deep fill ☹️
- Clayey Surficial Deposit ☹️
- Low volume, slow flow of water 😊

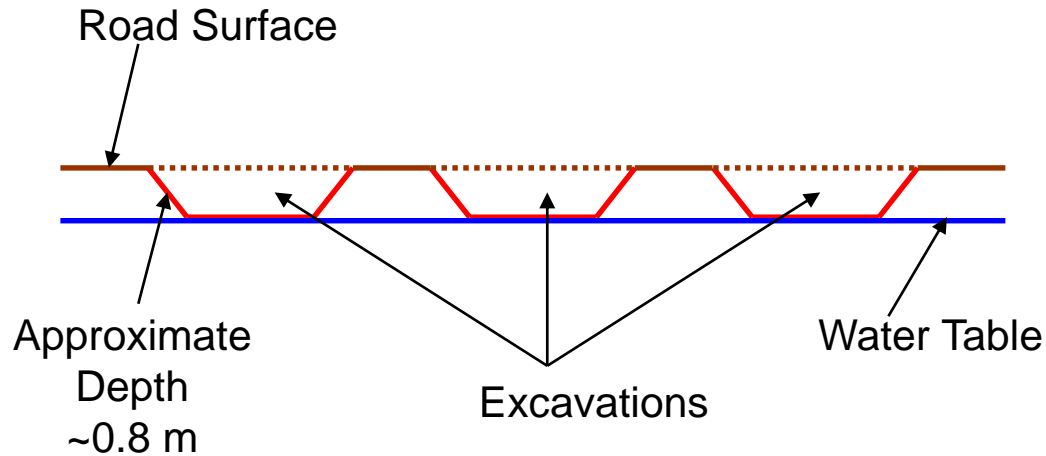
Road Excavation

- 2 prior seasons of water table observations
- 3 excavations as replicate “blocks”
- January excavation
 - Reduced impact from equipment
 - Logistically easier
 - Still some water flow

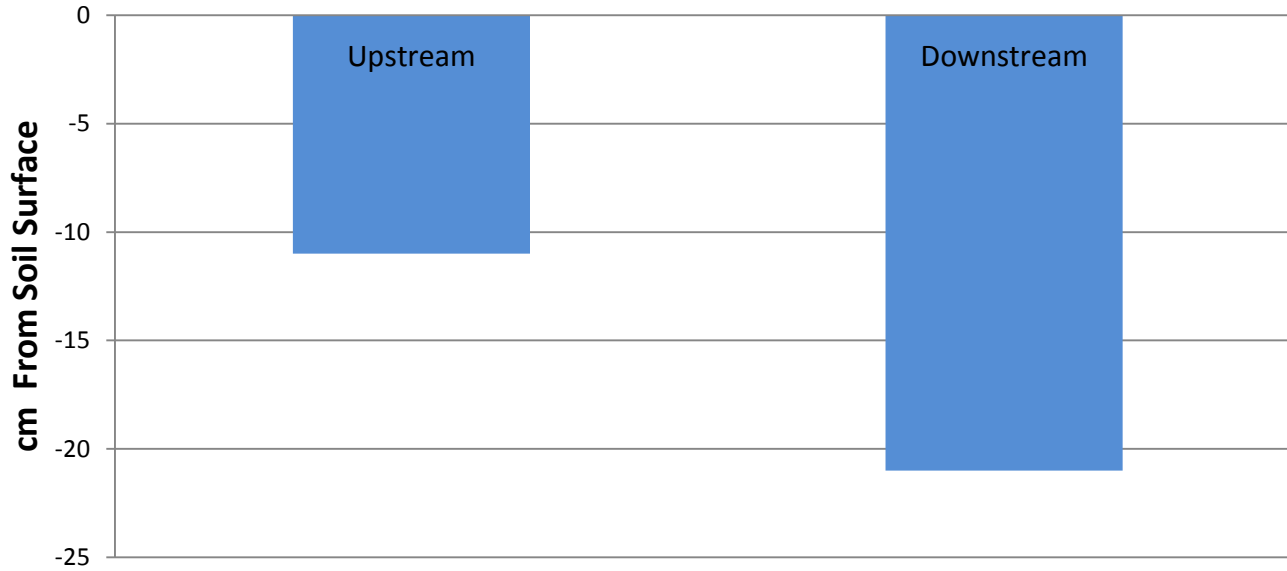
Water Table Level

- Road has impeded water flow
 - Water table and moisture differences between upstream and downstream sides of road
 - Some impact on vegetation
 - Minor impact on peat
 - Little impact on carbon and nutrient dynamics
 - Impacts may have been greater with higher water flow
- Lowering road surface did not sufficiently improve water flow
- Water table differential on opposite sides of road make managing water table on road difficult

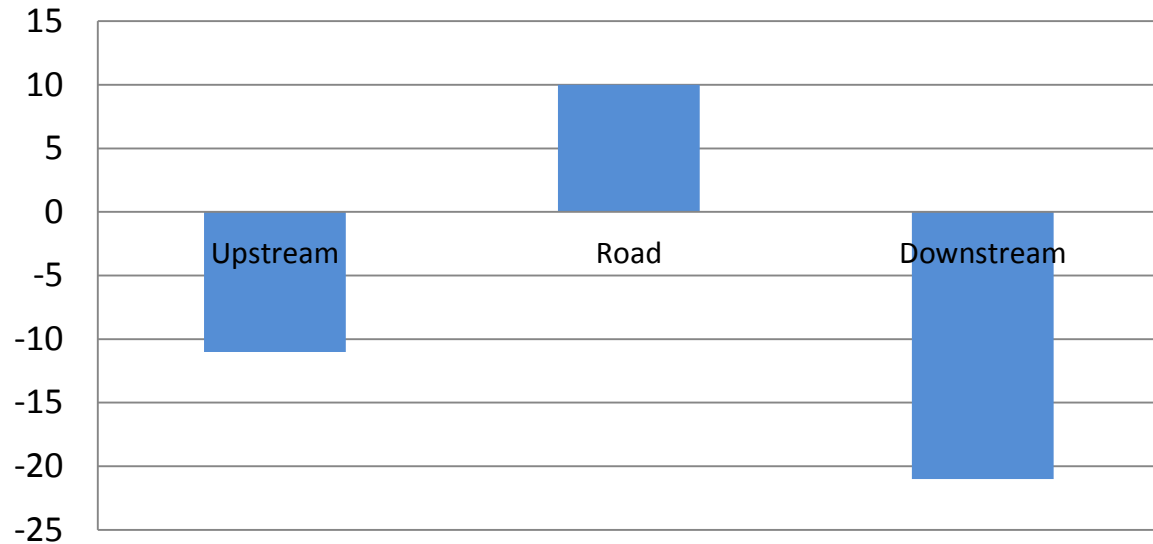
Water Table Level

- Water table is below soil surface both upstream and downstream
- Water table is above soil surface on road for at least part of the year
 - Excavation surface is lower than adjacent peat surface
- Fill surface is poor substrate and difficult to revegetate

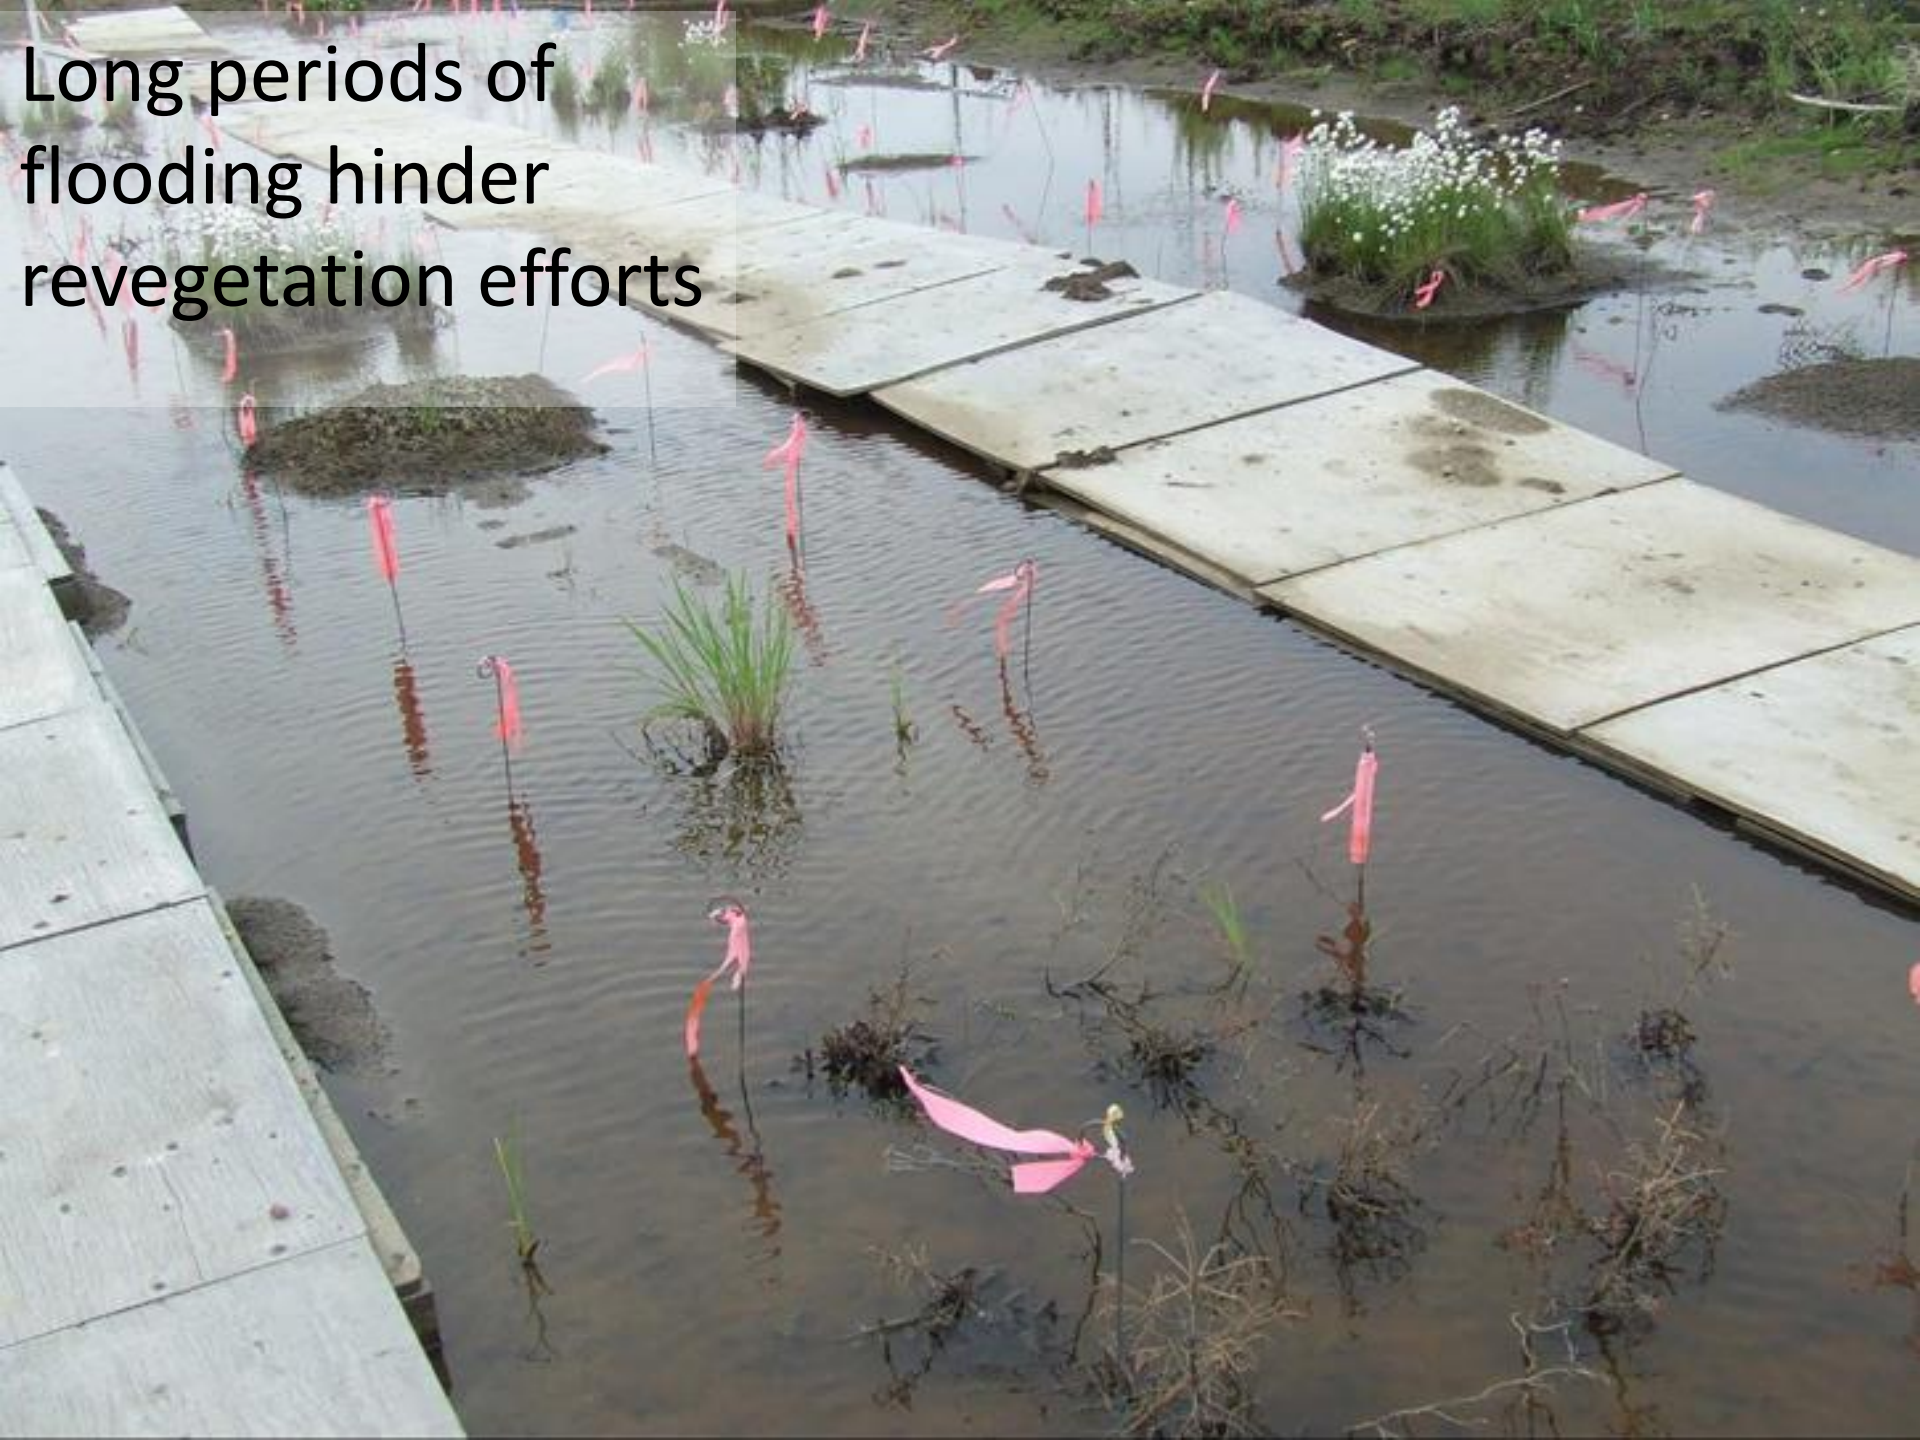
Long periods of
flooding hinder
revegetation efforts

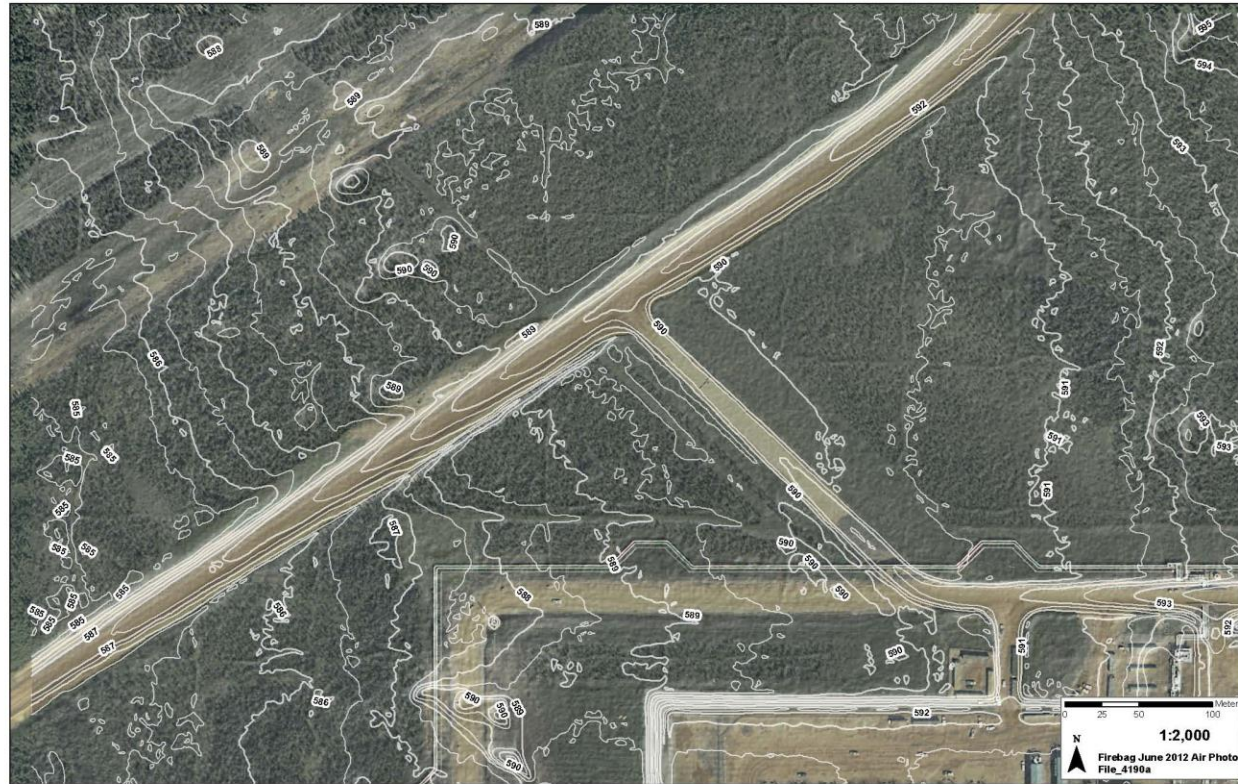
Site Description

- Shallower peat 😊
- Shallower fill 😊
- Sandy Surficial Deposit 😊
- Low volume, slow flow of water 😊

- Gravel-capped clay fill road on fabric liner over fen peatland.
 - 250 m long
 - 6 years old
- Clay thickness: 1.4 – 1.7 m
- Compressed peat thickness: 0.7 – 1.4 m
- Underlain by sand
- Evidence of vegetation mortality due to flooding on the upstream side

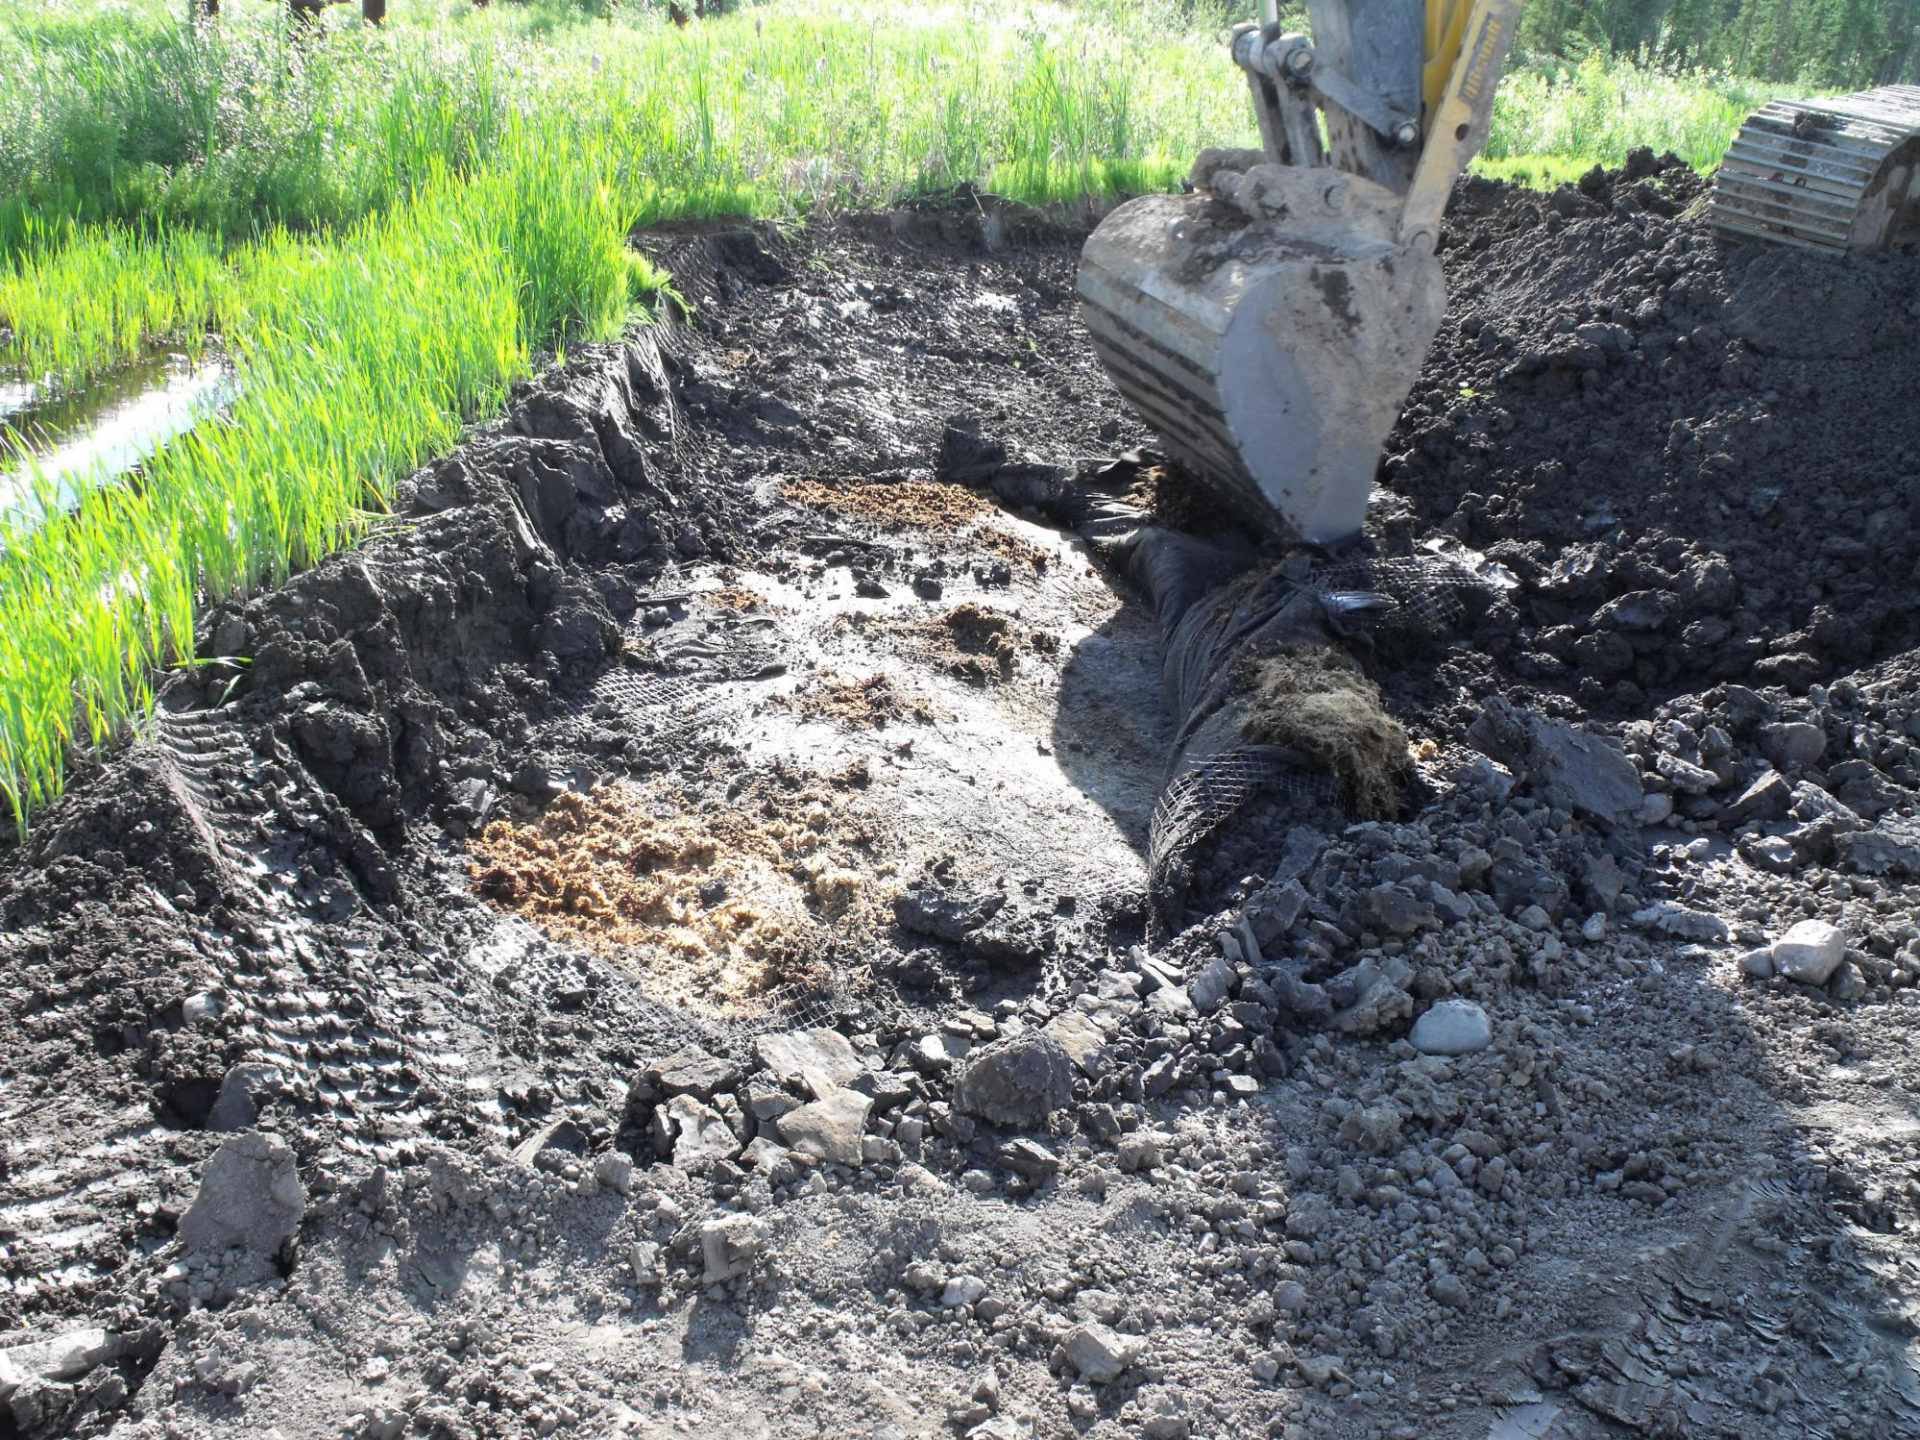
- Progressively removed fill and carefully removed liner from one end to the other
- Pumped water off at excavation front to keep working area “dry”
- Organics and very wet soil along apron, as well as liner and geo-grid separated and land-filled
- Drier material hauled nearby onsite for parking lot construction
- Start to finish approximately two weeks, 10 full days of work

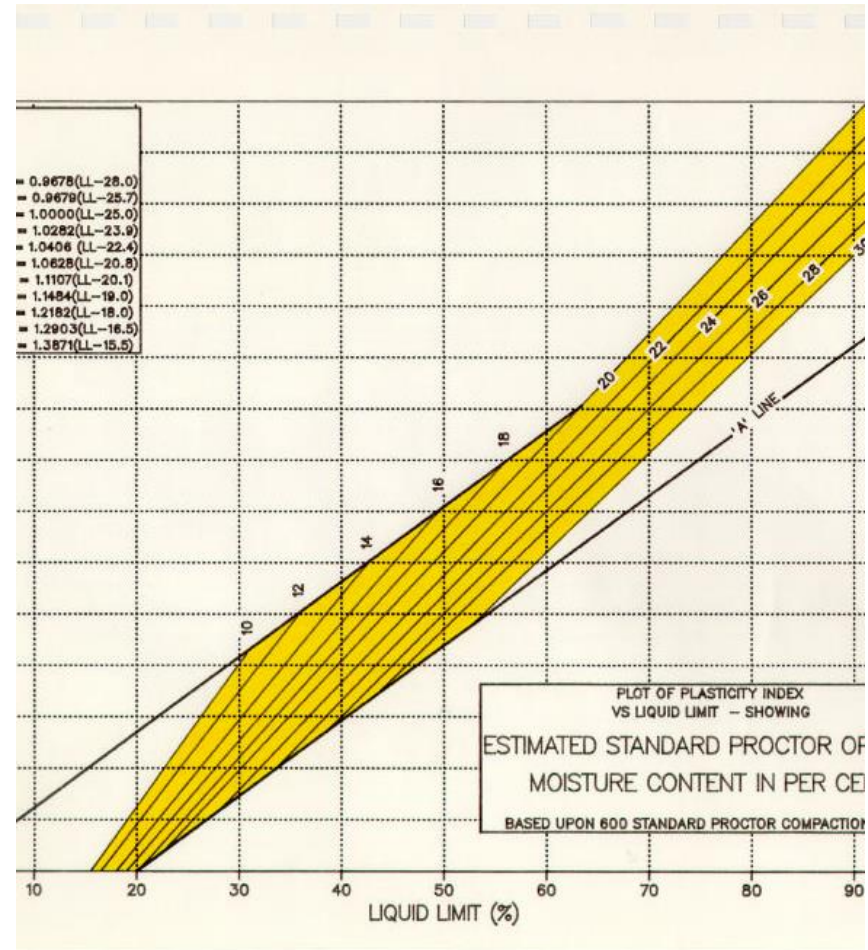
- Estimated maximum density:
- 1844 (kg/m³)
- Estimated optimum moisture to achieve max density: 13.8%
- Moisture of samples:
- Mean = 11.5%
- Range = 8.1% - 14.2%
- (2 of 72 samples >13.8%)

(From: AB Transportation Method TLT-413 (02))

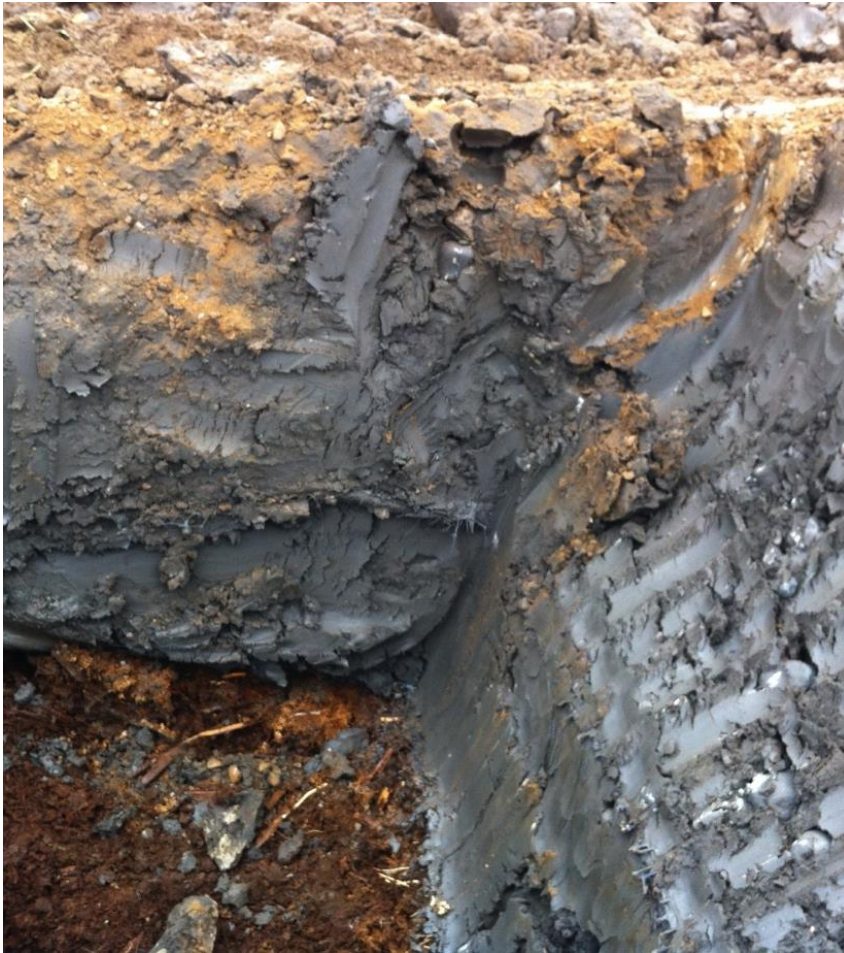
Fill Volumes

- Total volume of fill removed (m^3):
 - Gravel: 181
 - Mud, organics, liner material: 987
 - Useable clay: 4866
- Useable clay as a proportion of clay fill = 83.1%
