INTEGRATED REPORT

Canada's Oil Sands Innovation Alliance (COSIA)

Bioengineering and Conventional Erosion and Sediment Control Solutions for Oil Sands Operations

May 2018

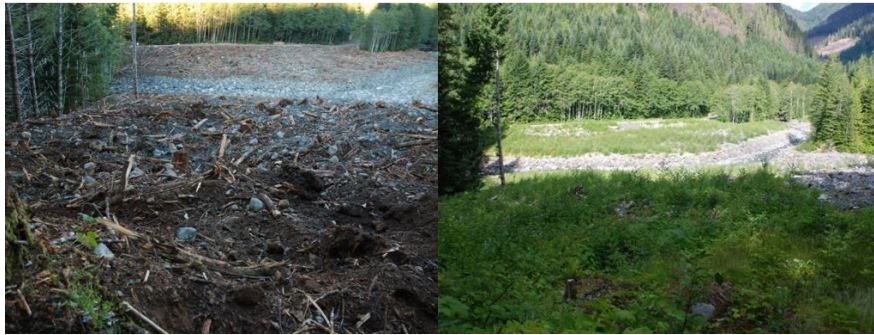
Figure 2-2

Rough and loose ground surface with woody material can be used to control erosion and promote the recovery of large disturbed sites. None of the vegetation in this photo was planted on site; but established after 5 years from the treatment.

Making ground rough and loose and scattering 100 m³/ha of coarse woody material on the surface will foster the establishment of pioneering species (Figure 2-2). This will then initiate the natural plant community successional trajectories and will ensure that the site maintains a healthy vegetation cover into the future. By encouraging the natural recovery processes to function on a disturbed site, the need to plant expensive native species is reduced or eliminated since the pioneering species are designed to initiate plant community development on the site.

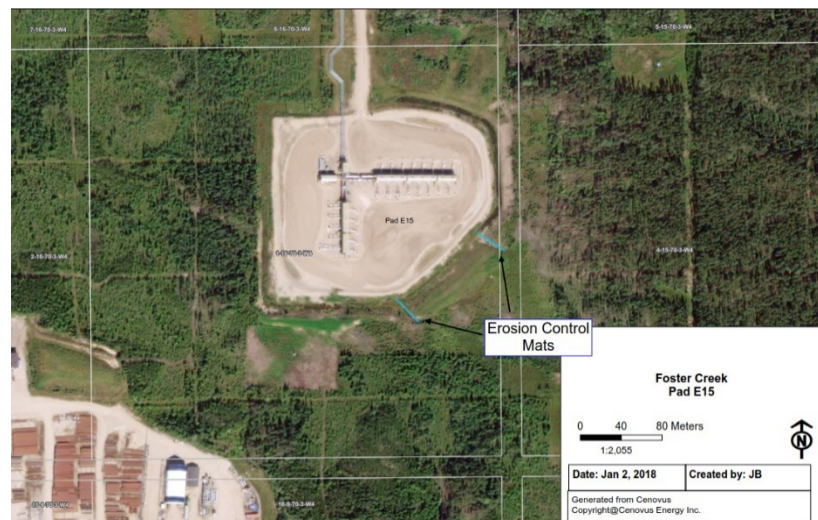
Figure B-1
Two drainage ditches lined with erosion control mats and riprap at Well Pad E15 at Foster Creek.

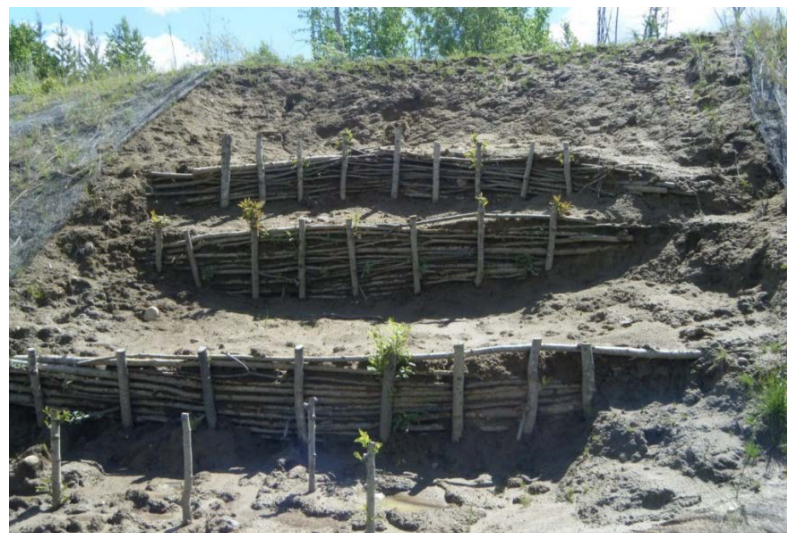
Figure B-2
Wattle fence installation after erosion control matting failed (June 27, 2012).

Lessons Learned:	<p>Erosion control mats failed after a few months (even though they had been keyed to the ground correctly), as water got underneath the geotextile cloth (Figure B-4 and B-5).</p> <p>Wattle fence construction was difficult and at the time, permission was needed from the AER to harvest willows from the lease. Willow harvesting was labour intensive; they were cut by hand using a team of 6 people over a one-half day. Accessing the willow harvesting site proved to be a challenge.</p>

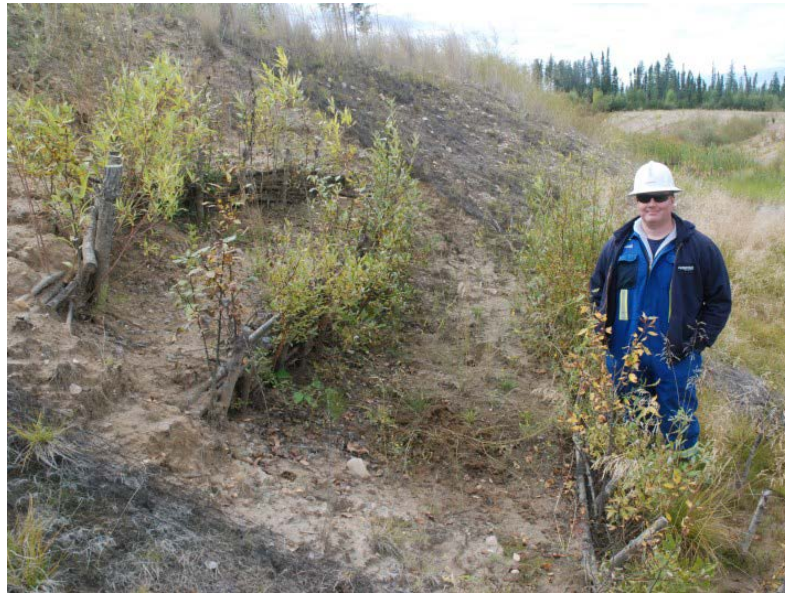
Figure B-3
Successful establishment of the wattle fence; growth two years
after installation (September 10, 2014).

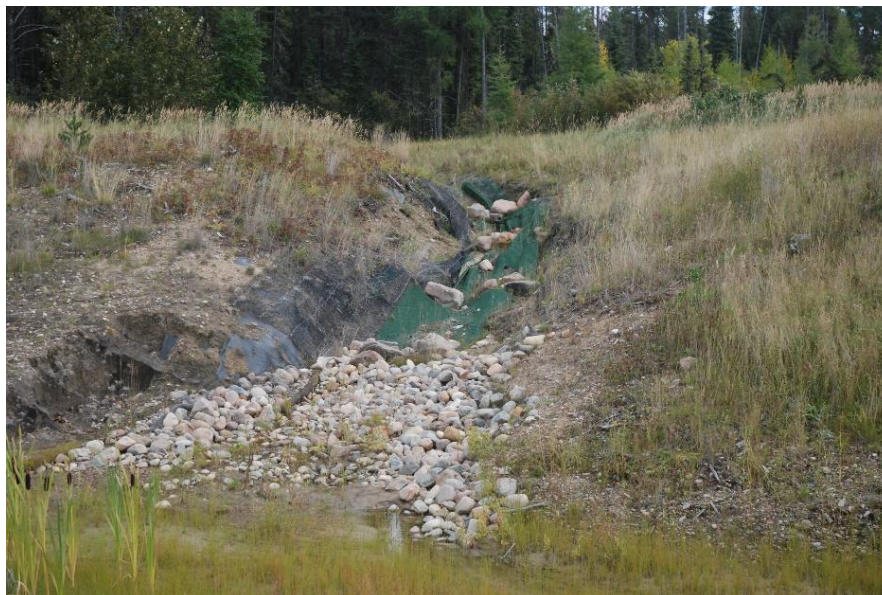
Figure B-4
Erosion control mat installed along southeast slope and water
has begun eroding under the mats.

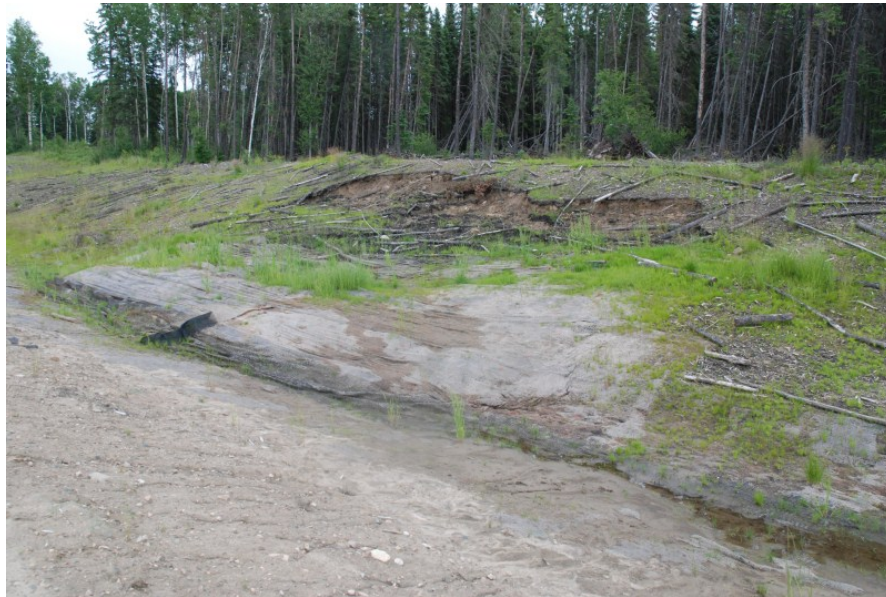
Figure B-6
Slumping and erosion control mat failure along the east side.

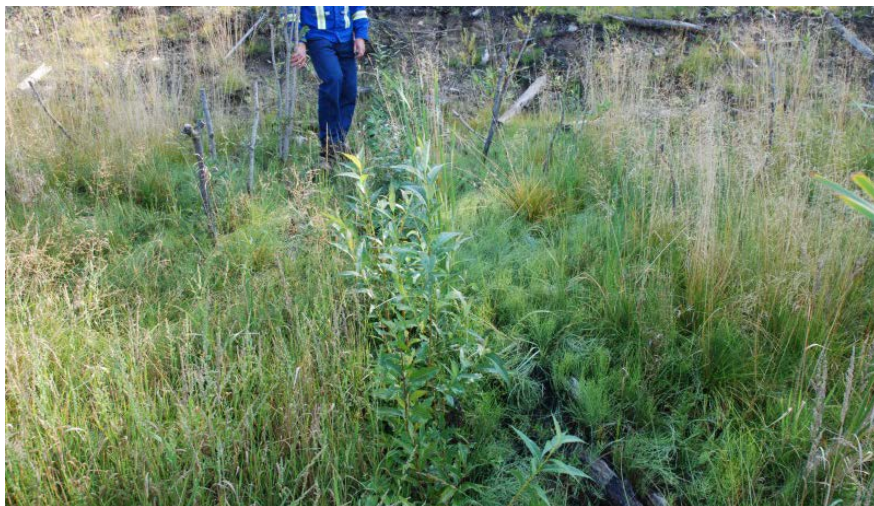
Figure B-8
Live pole drains used to reduce excess water that had lead to slope failure (August 27, 2012).

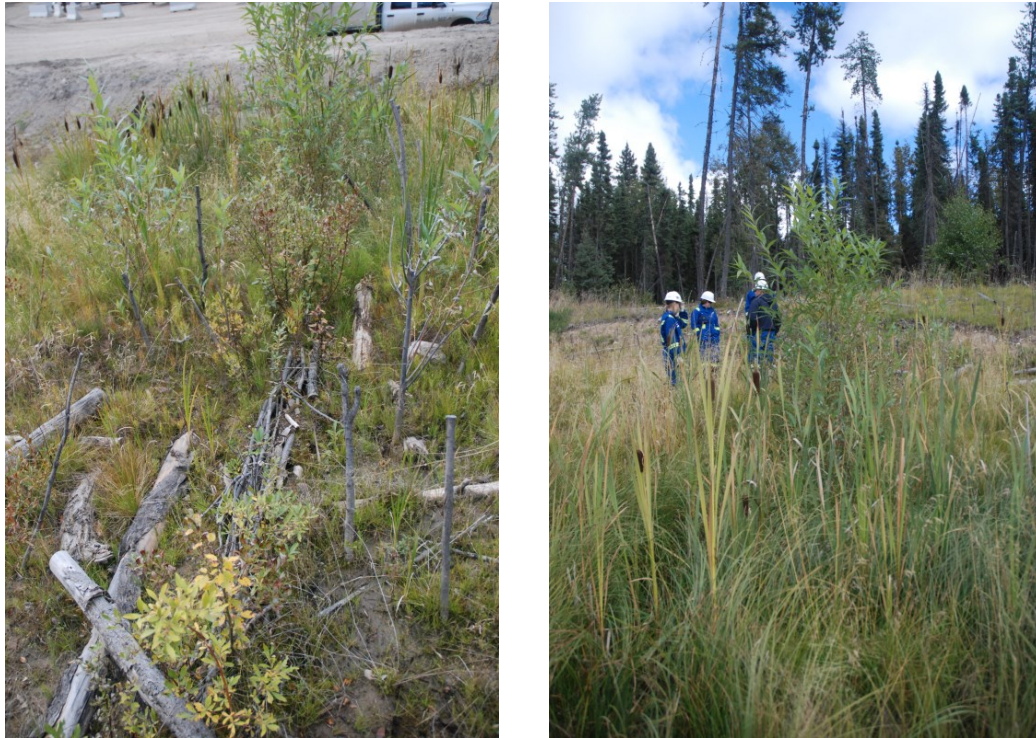
Figure B-9
Live pole drain establishment (September 10, 2014).

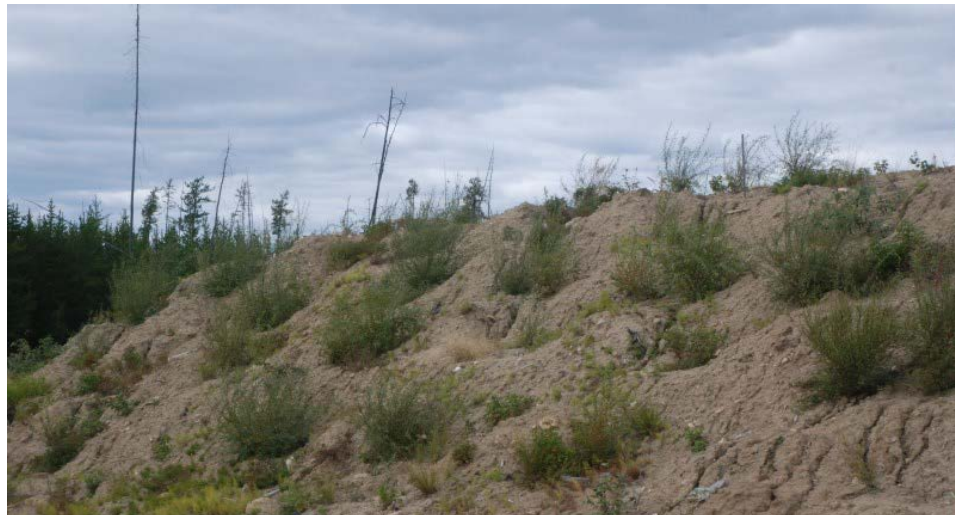
Figure B-11
Rough and loose topsoil stockpile supporting a healthy growth of willows and other plant species (September 10, 2014).

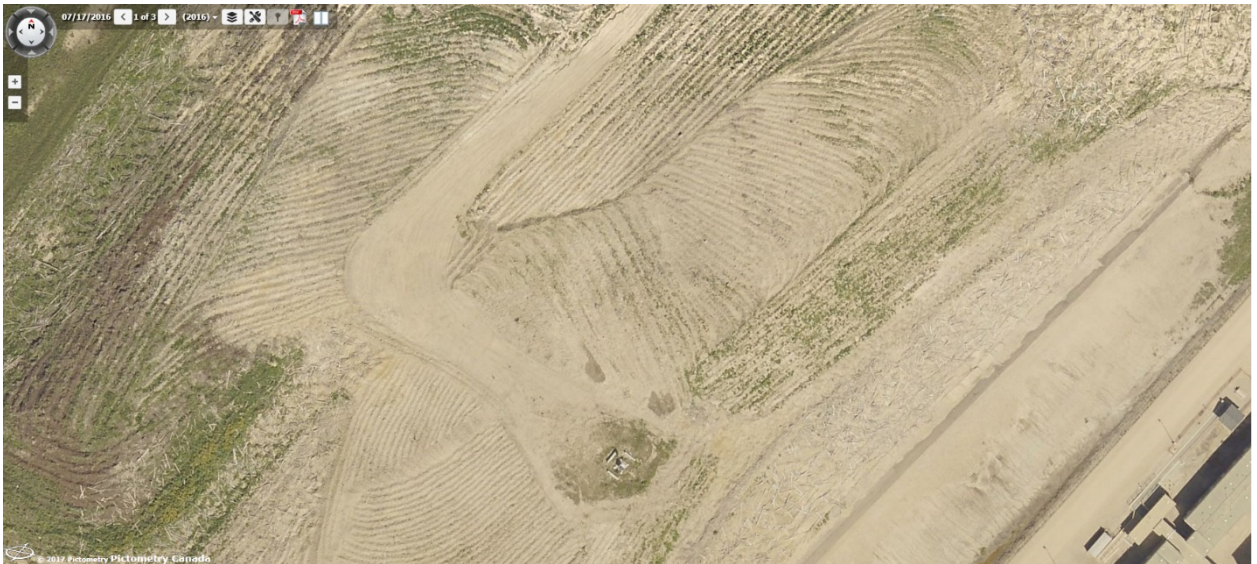
Figure B-12
Rough and loose site preparation and coarse woody material application completed fall of 2015. Vegetation trials planted June 2016 (image taken July 17, 2016).

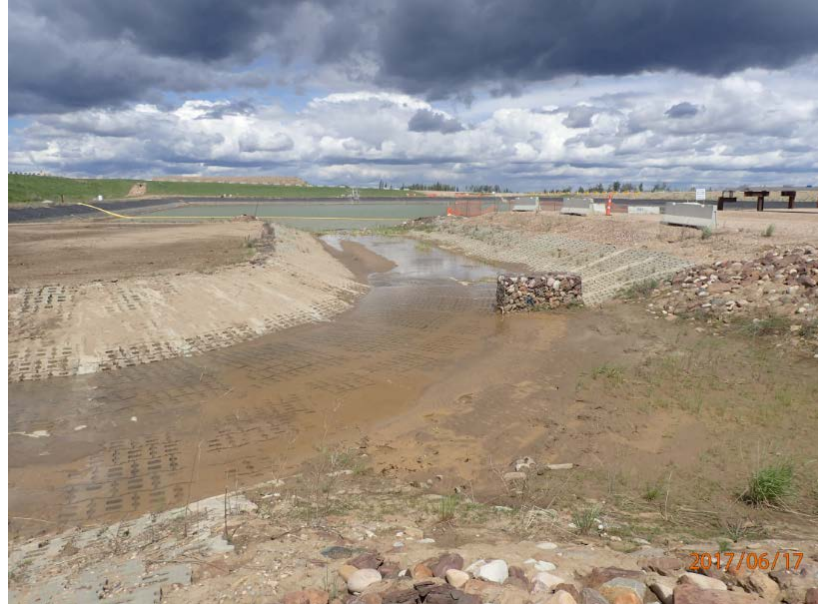
Figure B-15
Spillway at CPF illustrating the various conventional ESC
measures used to manage erosion.

Conventional approaches along the spillways have often failed, creating rilling and gullies. These spillways are steep with 3:1 (18°) slopes, so geotextile and rocks wash-out with high runoff flows (Figures B-16 to B-18). A recommended improvement includes the addition of rock blankets or use of sticks to keep rocks in place along spillways.

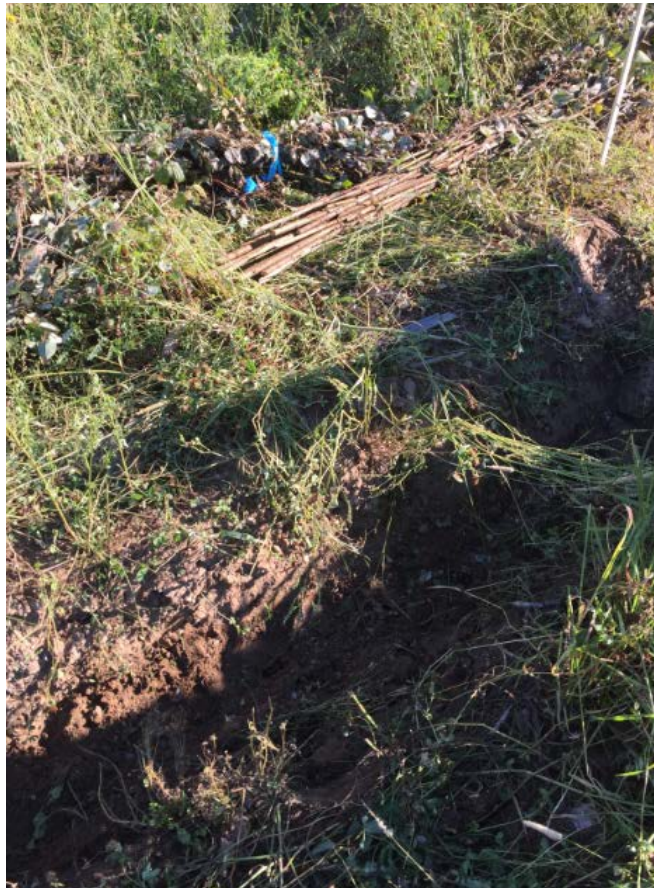
Figure B-19
Trench and live pole drain prior to installation at 12-24-083-06 W4M.

Site Conditions:	Groundwater seeps were encountered 12-24-083-06 W4M.
Conventional Approaches:	N/A
Bioengineering Approaches:	In the summer of 2017, two live pole drains made of balsam poplar cuttings were installed on ~3:1 (18°) slopes (Figure B-19).
Successes:	Unknown until Spring 2018.
Lessons Learned:	It was challenging to find qualified people to install the live pole drains. Original trenches dug in the winter were far too deep, and extra labour and expense were required to partly refill the trenches. The timing of the cutting collection in late August was sub-optimal.

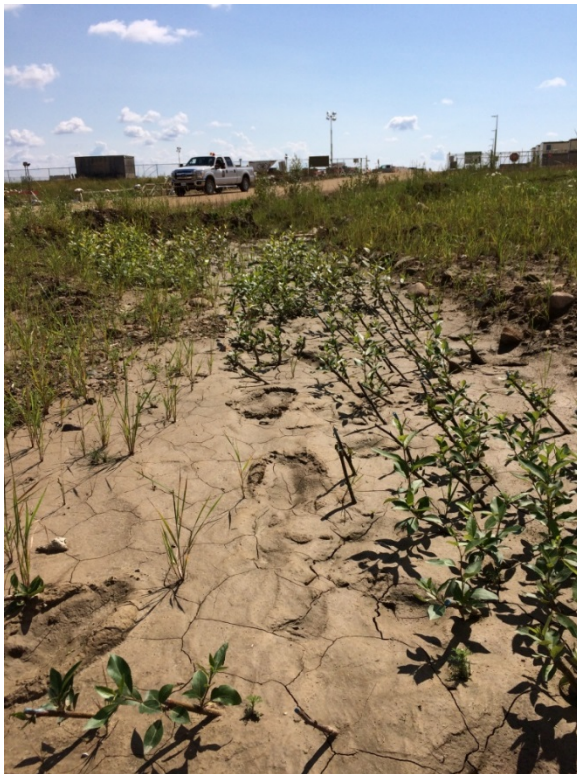
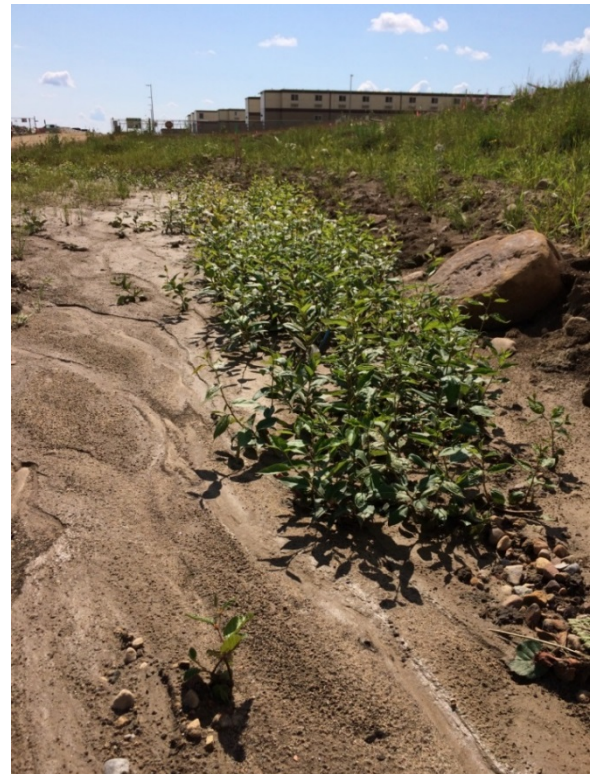
Figure B-20
Live staking survival and re-growth at Surmont.

Site Conditions	Roadside prone to sedimentation at base of stockpile.
Conventional Approaches:	N/A
Bioengineering Approaches:	The site was planted with rooted balsam poplar stakes (Figure B-20) and 150 – 200 live stakes were planted approximately 5 to 10 cm apart to catch sediment.
Successes:	Live silt fence grew successfully in the first year and is capturing sediment on-site.
Lessons Learned:	N/A

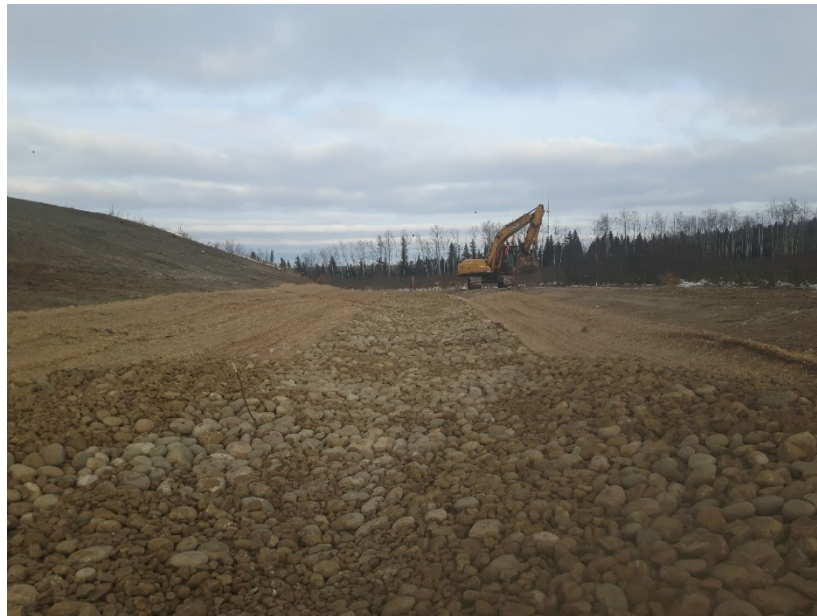
Figure B-23
Coconut matting with riprap armouring a drainway at the Kinosis Borrow Pit.

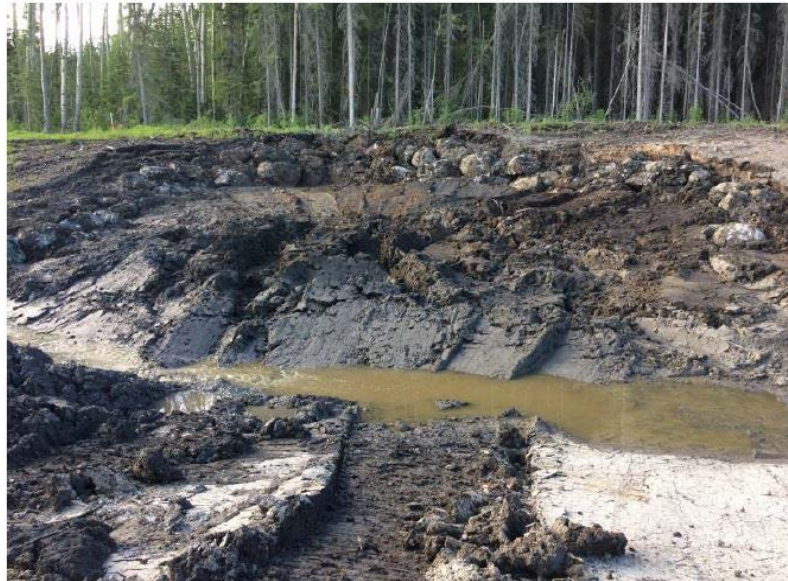
Figure B-27
A view of large boulders and saturated materials along the MPAR.

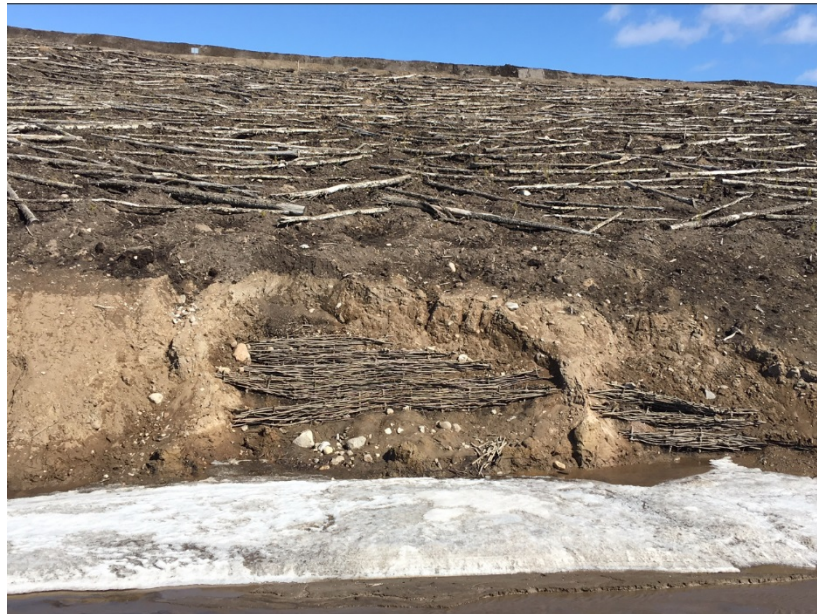
Figure B-29
Four-tiered wattle fence constructed along a 5:1 (11°) slope on overburden dump.

Site Conditions:	An overburden stockpiles with 5:1 (11°) slopes required stabilization.
Conventional Approaches:	N/A
Bioengineering Approaches:	<p>Wattle fences were installed as part of a pilot project at two slope failure locations on the overburden stockpiles. One area was 4 m wide and a 4-tier wattle fence was installed, and the second area was 6 m wide and the wattle fence consisted of 6-tiers (Figure B-29).</p> <p>Wattle fences were constructed of willows cut roughly to 1.5 to 2 m lengths with diameters between 2 to 4 cm. Wattle fences were installed at the toe of the slope and backfilled using peat (Figure B-30).</p>
Successes:	Fences were installed in October 2017 and the site will be evaluated in spring of 2018.
Lessons Learned:	Certified professionals were hired to design and install the fences.

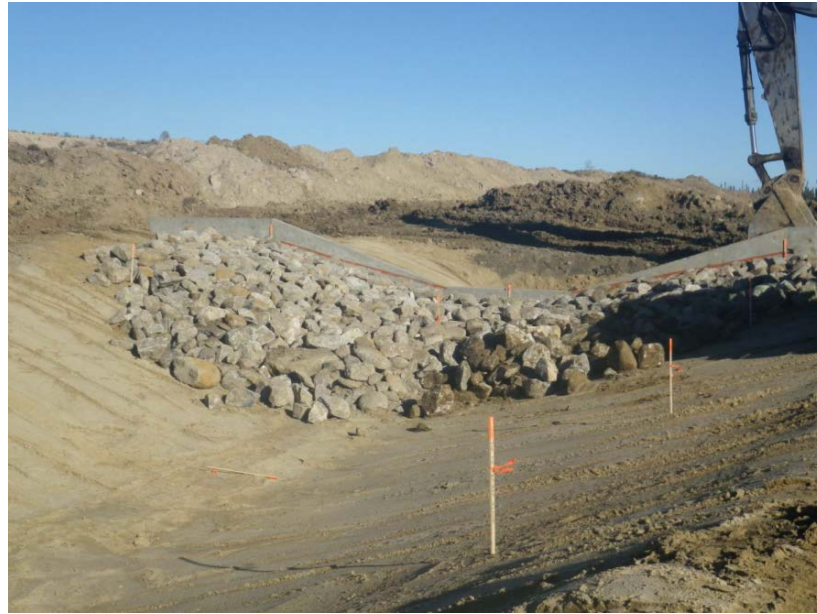
Figure B-31
Drop structure installed along a perimeter ditch with riprap armouring at MD9.

Site Conditions:	Since 2013, several perimeter drainage ditches have collected water from Mine Dump 9 (MD9) and divert it to settling ponds prior to release into natural drainage channels and watercourses. The average grade of these ditches is approximately 96:1 (.6°).
Conventional Approaches:	Drop structures are used to control erosion in approximately 13 ditches around MD9 (Figure B-31). All inlets and outlets of culverts are lined with riprap. A buildup of sediment does occur in these ditches overtime and needs to be removed.
Bioengineering Approaches:	Several ditches have revegetated through natural succession over a five to 10 year period. In some cases, ditches have been treated with hydroseeding, but grasses failed to establish using this approach due to lack of rain or thin topsoil.
Successes:	Native grasses and cattails have established naturally in some ditches.
Lessons Learned:	In some cases, ditches were treated with hydroseeding, but grasses failed to establish using this approach due to lack of rain or thin topsoil.

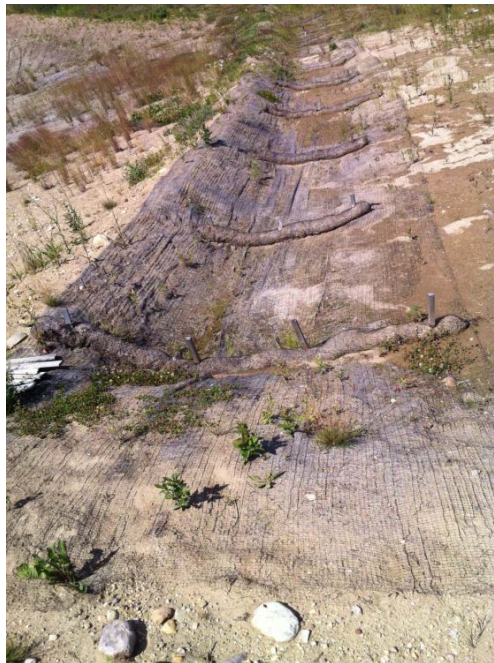
Figure B-34

A swale lined with erosion control matting and straw coirs that convey water off-site.

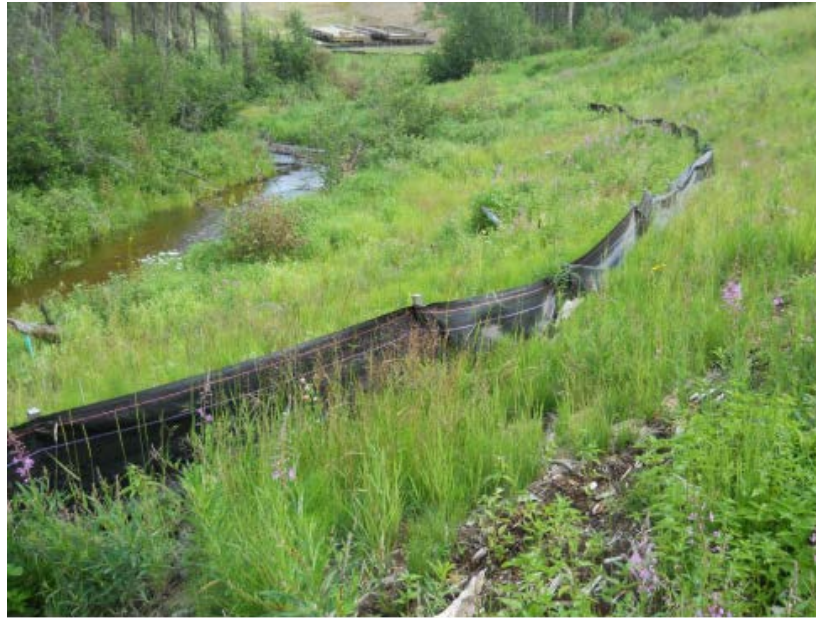
Figure B-35
Silt fence and revegetation near Clarke Creek.

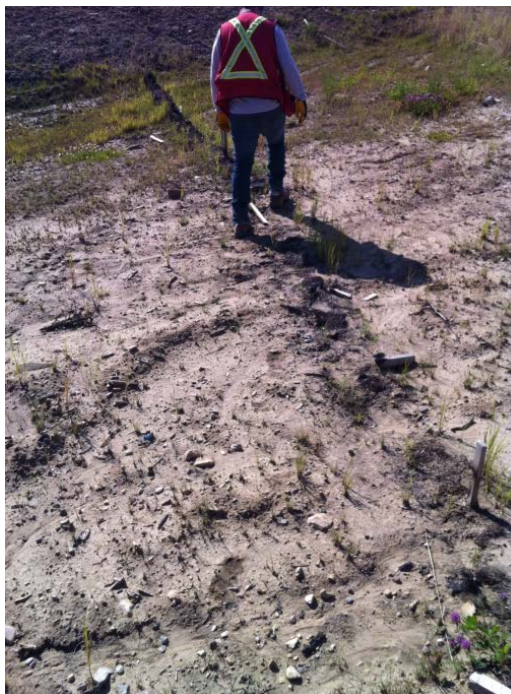
Figure B-36
A silt fence burnt by 2016 fire. Remaining soils have poor vegetation cover.

The 2016 Fort McMurray fire damaged or destroyed some of the ESC measures (Figure B-36), and herbivory has occurred on some of the straw coirs (Figure B-37).

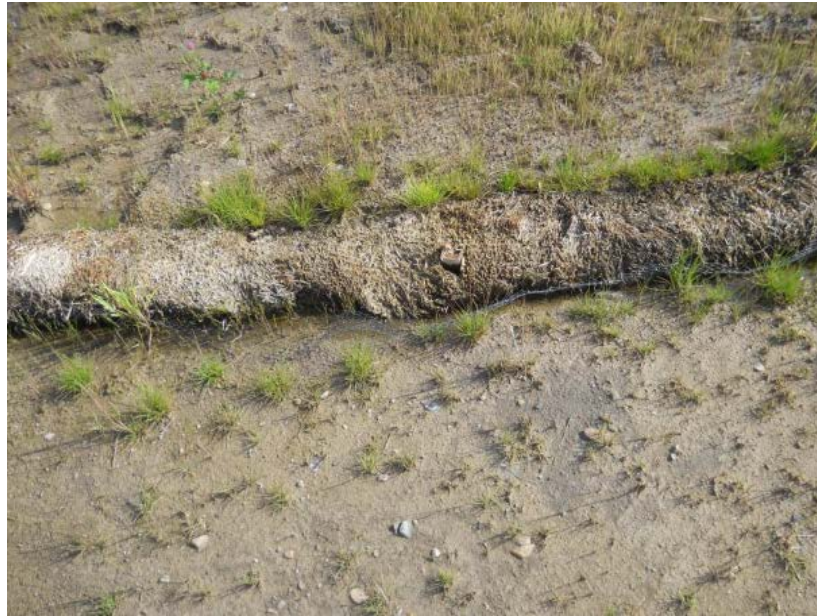
Figure B-37
Evidence of herbivory on straw coir rolls.

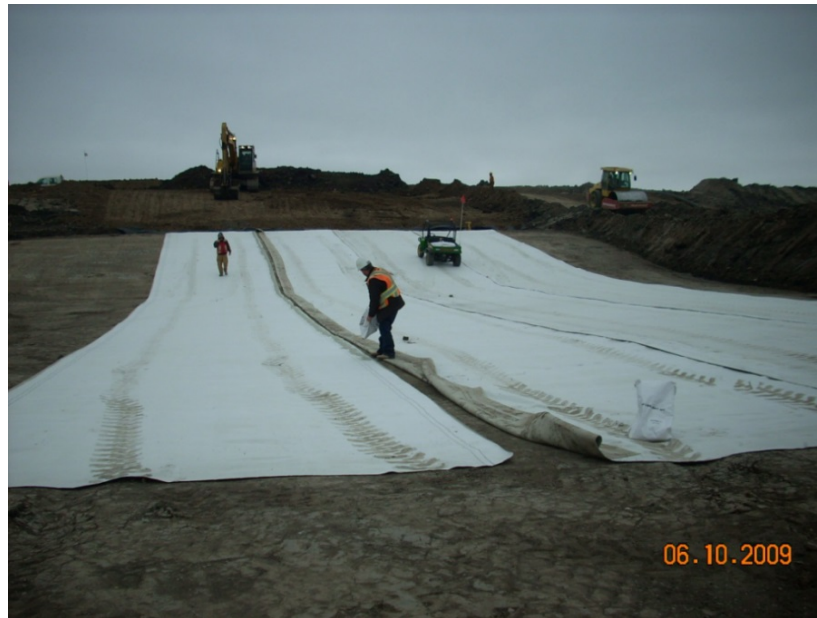
Figure B-44
Installation of the geosynthetic liner in compensation lake with a 12-inch overlap between sheets.

Successes:	Vegetation is growing through the coconut matting around the lake.
Lessons Learned:	<p>The biodegradable geosynthetic liner used around the lake did not break down after two years (still intact seven years after installation) and as a result, the surface has become unstable and slippery, and is separating from the soil.</p> <p>Establishment of the planted vegetation has been slow around the lake.</p>

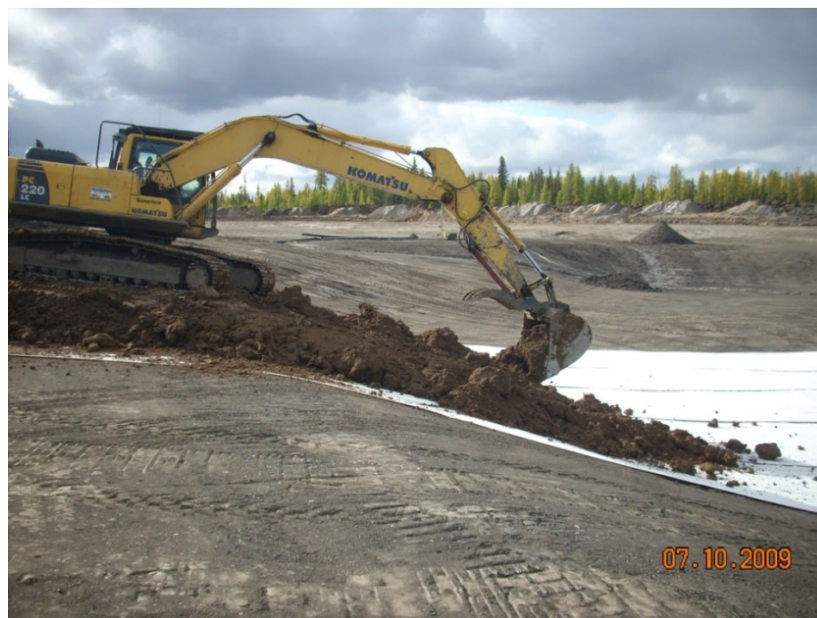
Figure B-45
Cover material application over the geosynthetic clay liner in compensation lake.

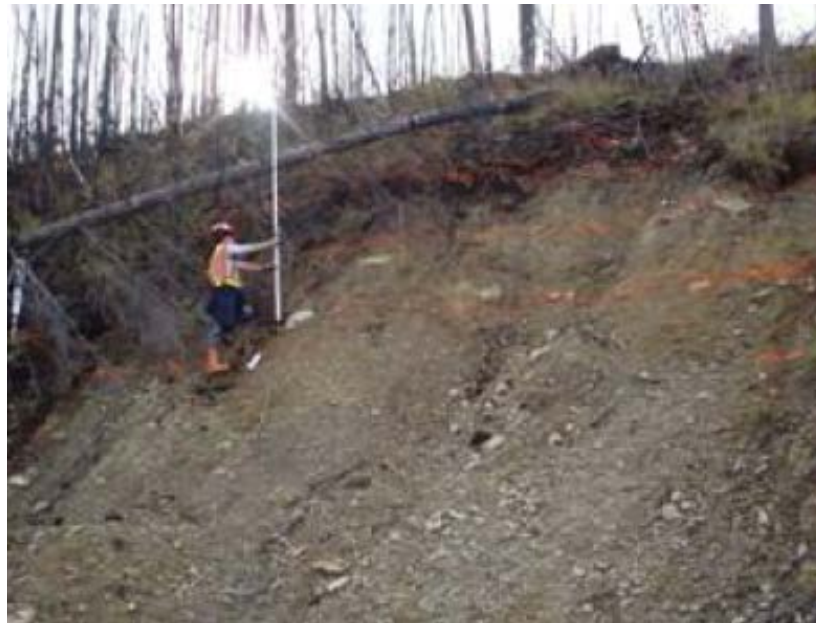
Figure B-48
Slope failure at Beaver Creek within the pipeline right-of way.

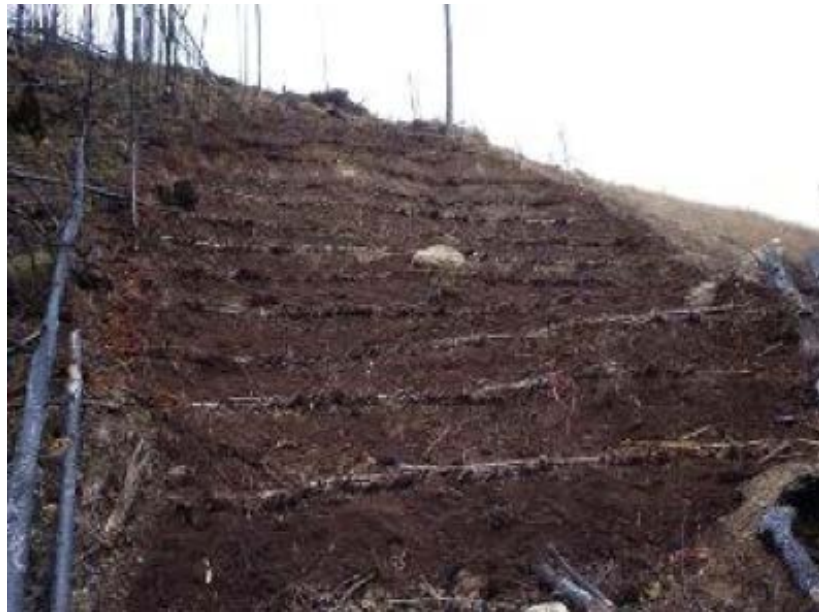
Figure B-49
Brush layers and live fascines installed on pipeline right-of-way, October 2004.

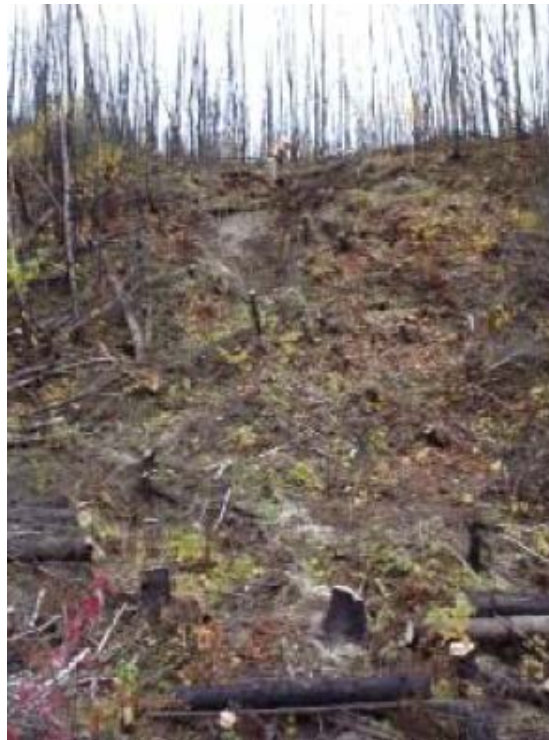
Figure B-51
Slope failure adjacent to Beaver Creek treatment area.

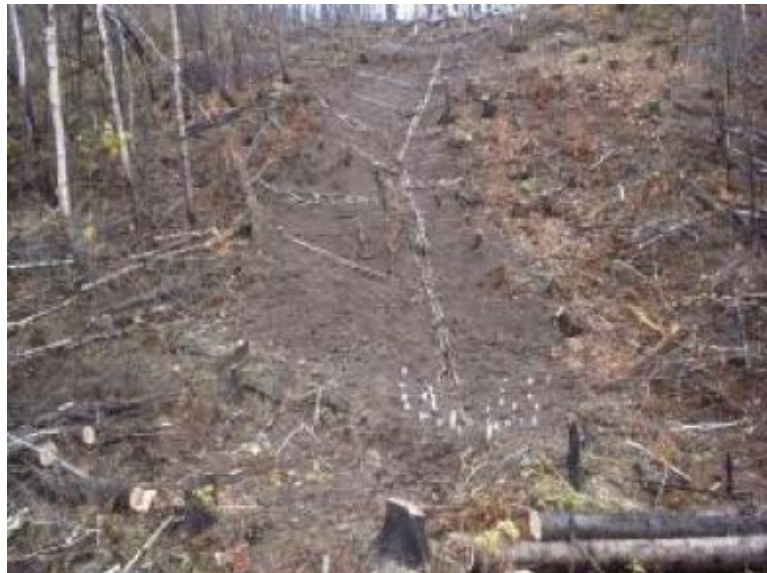
Figure B-52
Live pole drain installation at failure site, October 2005.

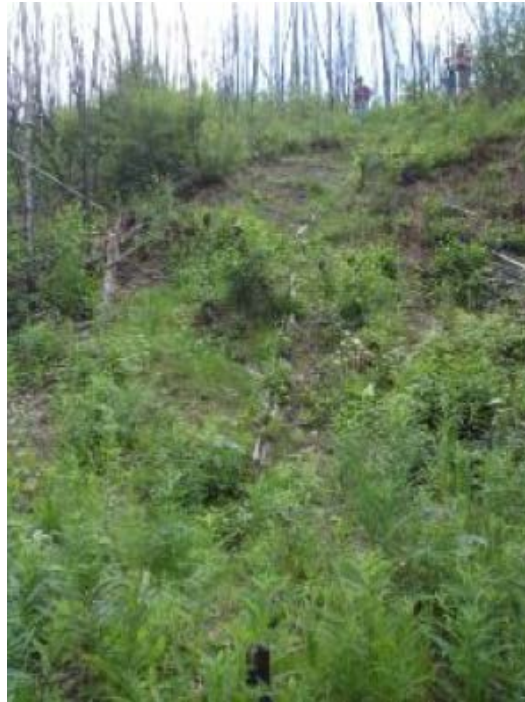
Figure B-53
Vegetation growth on slope failure adjacent to Beaver Creek
treatment area in June 2006.

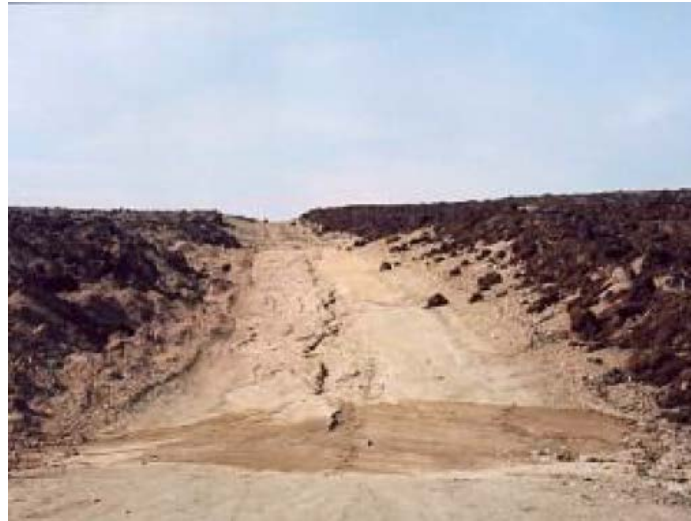
Figure B-60
Alpha swale prior to treatment, spring 2004.

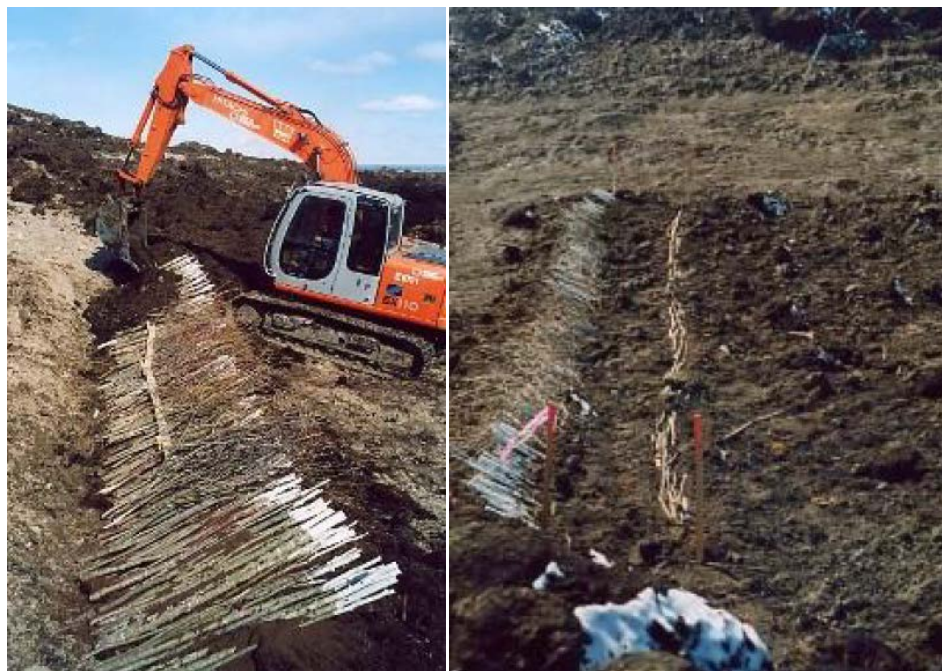
Figure B-61
Brush layering installation (left); live fascines used in combination with brush layering (right).

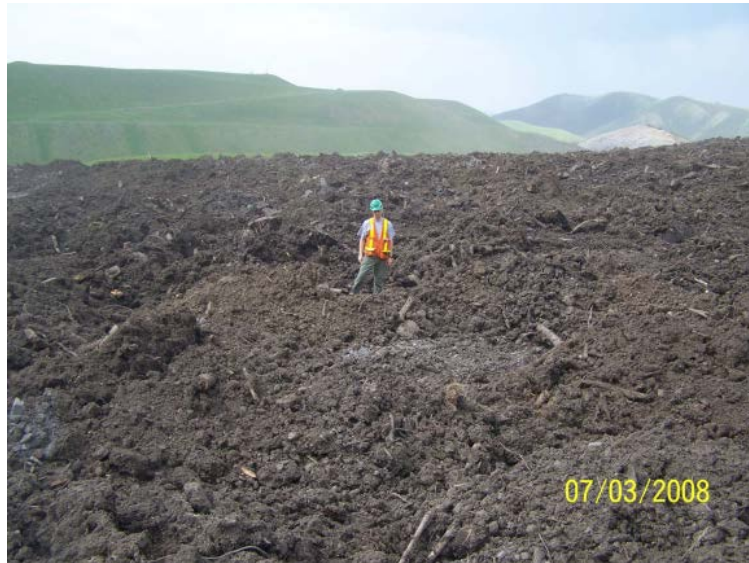
Figure B-65

Rough and loose placement of soils mixed with coarse woody material at Cheviot Mine.

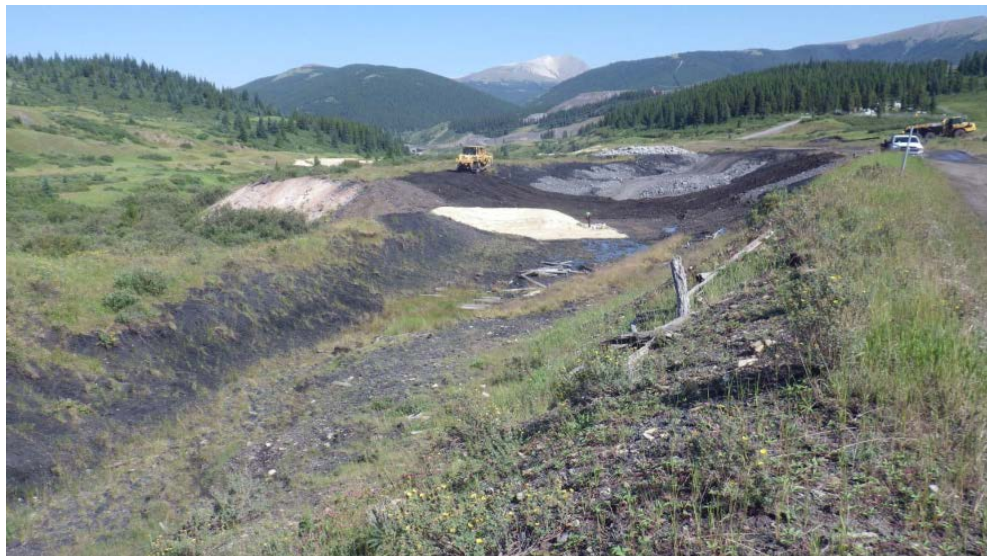
Figure B-68
Earthwork progress for the Upper McLeod River Habitat Enhancement project.

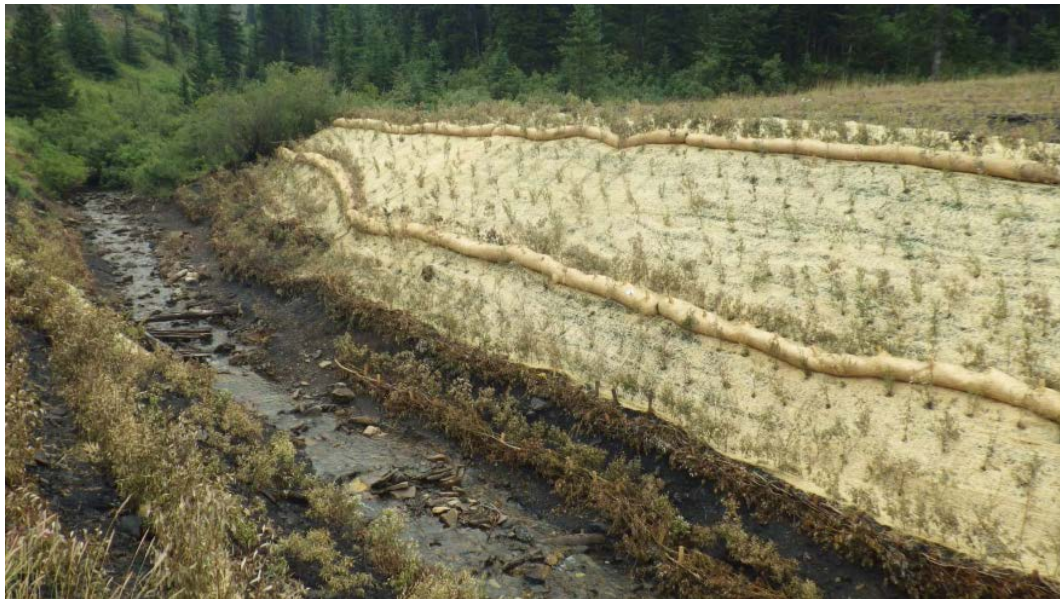
Figure B-69
Coconut matting and straw logs installed to protect
exposed soils along the McLeod River.

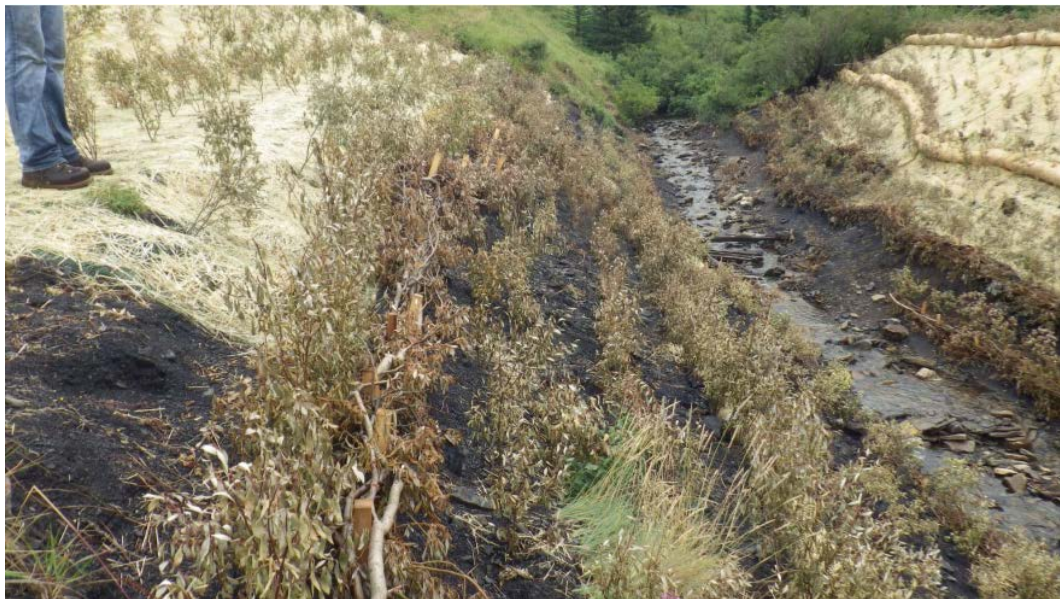
Figure B-70
Wattle fencing installed along a stream bank along the McLeod River.

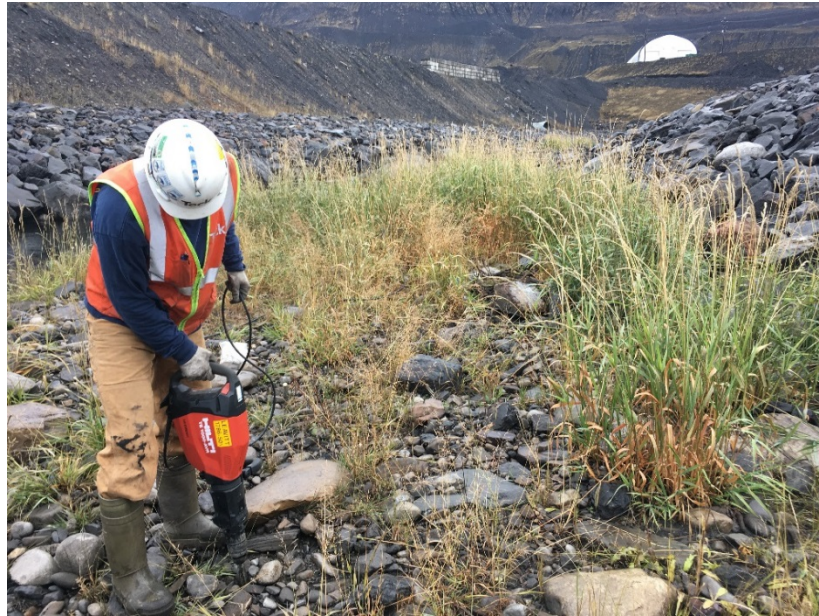
Figure B-72
Live cuttings were planted below the boulders.

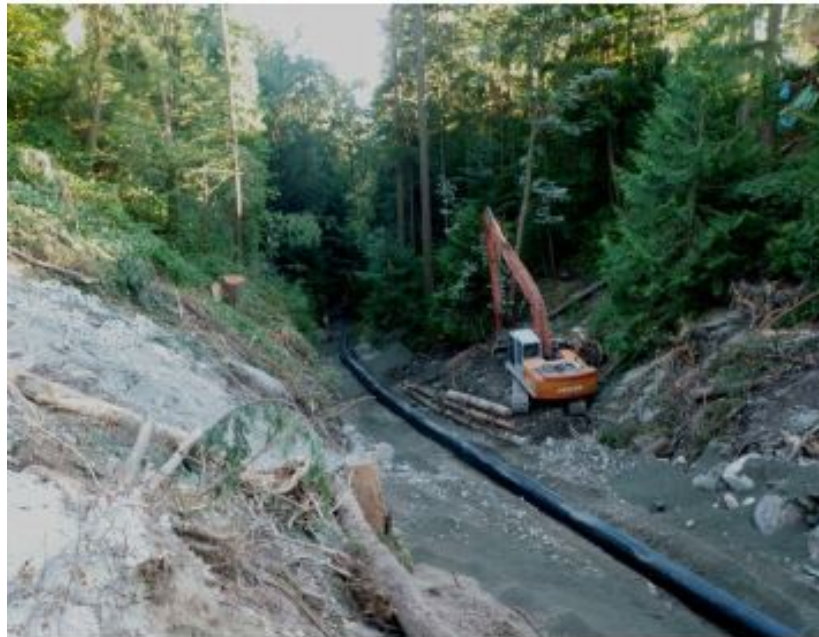
Figure B-78
Diversion pipe installation (2012).

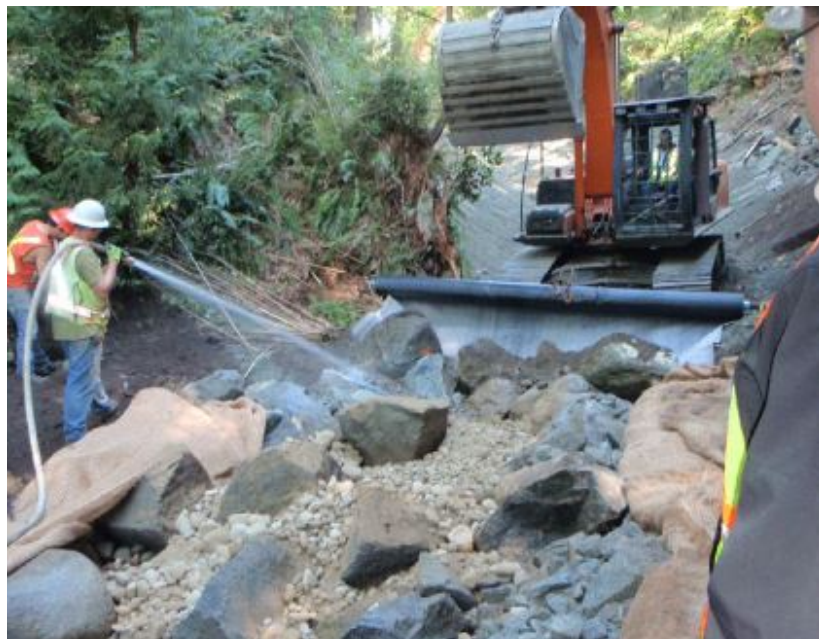
Figure B-79
Conventional techniques for ravine bed: geosynthetic liner, riprap, and large boulders (2012).

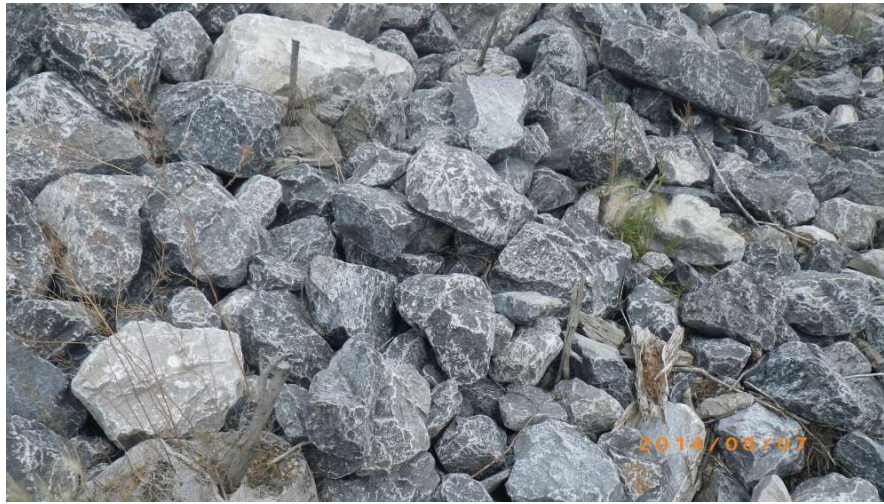
Figure B-82
Failed willow establishment within riprap along the Bow River.

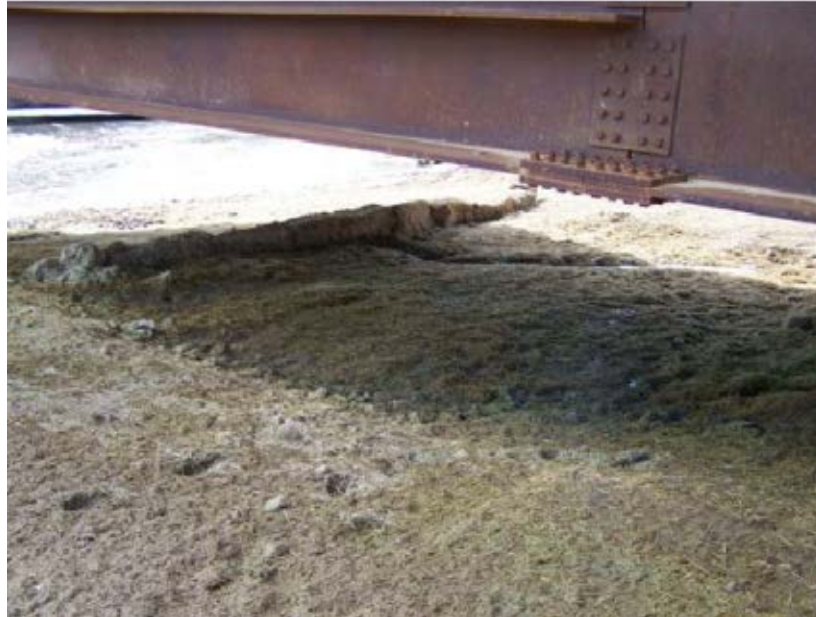
Figure B-83
Straw check-dams one year after installation.

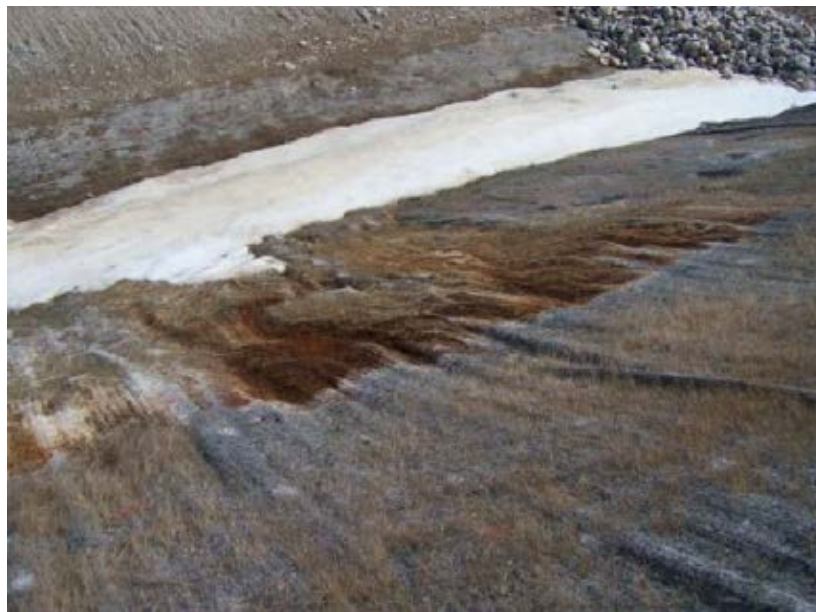
Figure B-84
Failing erosion control matting with minimal or no vegetation growth one year after installation.

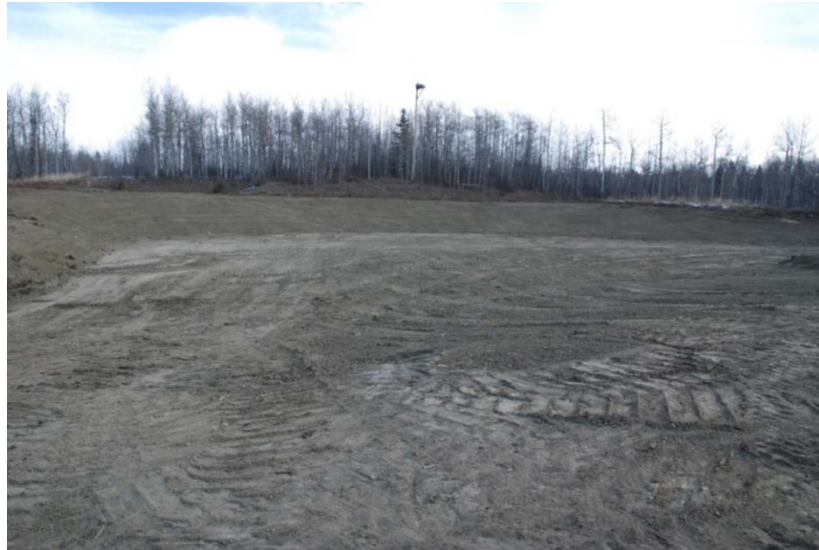
Figure B-91
Exposed soil at the gas plant was decontaminated and regraded (compacted and smooth).
