INTEGRATED REPORT

Canada's Oil Sands Innovation Alliance (COSIA)

Bioengineering and Conventional Erosion and Sediment Control Solutions for Oil Sands Operations

May 2018

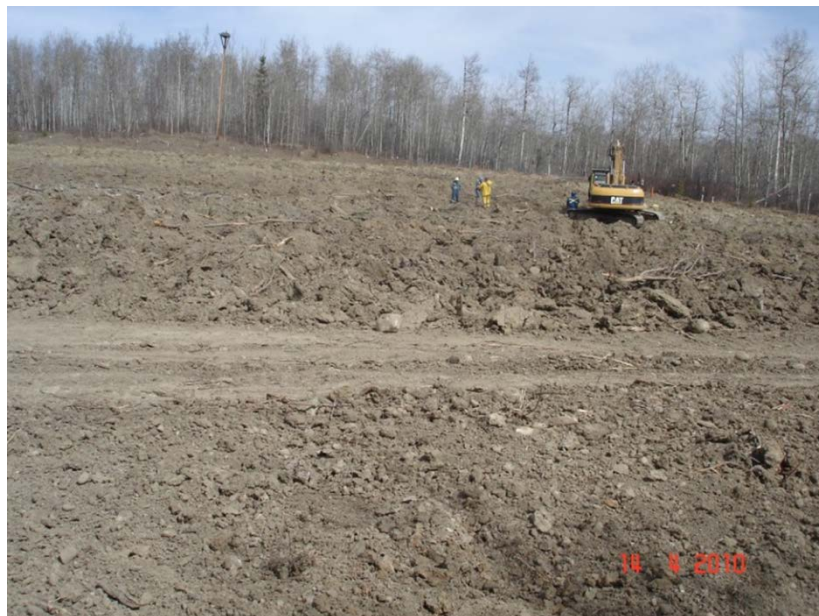
Figure B-92
Rough and loose soil treatment.
