BIOENGINEERING TECHNIQUES FOR REVEGETATION OF RIPARIAN AREAS AT THE COLOMAC MINE, NWT

Mary Hewitt¹, Morag McPherson² and Melissa Tokarek³

Proceedings of the 2013 Northern Latitudes Mining Reclamation Workshop and
38th Annual Meeting of the Canadian Land Reclamation Association

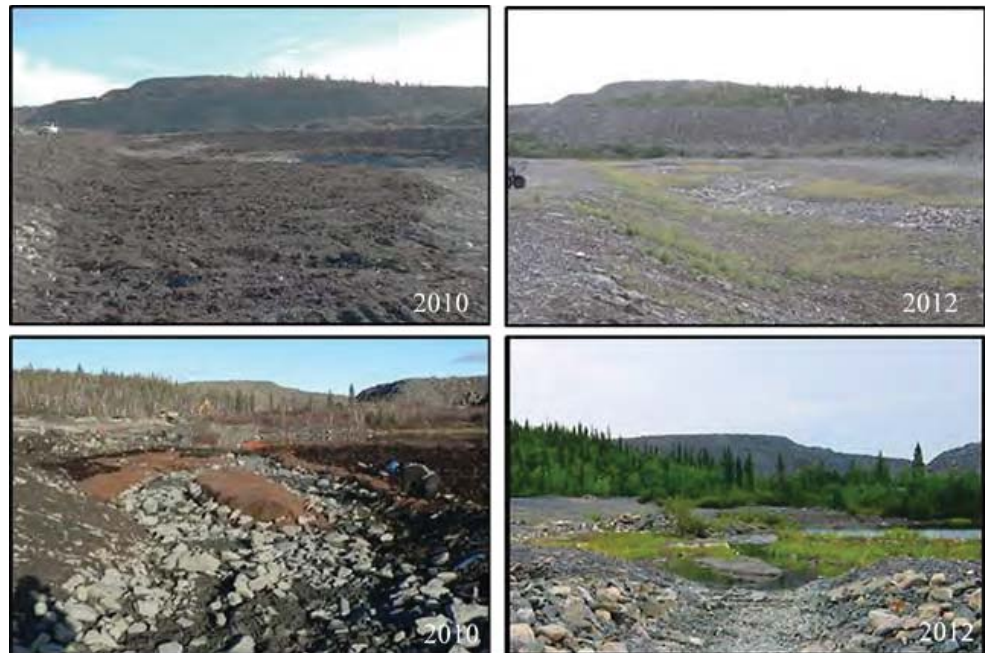
Figure 3. Top pictures, Truck Lake Channel before (2010) and after (2012) revegetation efforts. Lower pictures, Truck Lake Channel outflow area before (2010) and after (2012) revegetation efforts.

The wetland catchment area was ‘rough and loosed’, however, on the channel terrace the waste rock material collapsed in on the excavated holes and the checkerboard pattern of depressions and mounds could not be maintained. Erosion control mat was laid along the Truck Lake Outflow banks and islands to prevent bank erosion during spring freshet (Figure 3). Willow cuttings were planted with an excavator along the Truck Lake shore and channel, sedges were planted in selected areas along the channel and the whole area was seeded with alder and native grass.

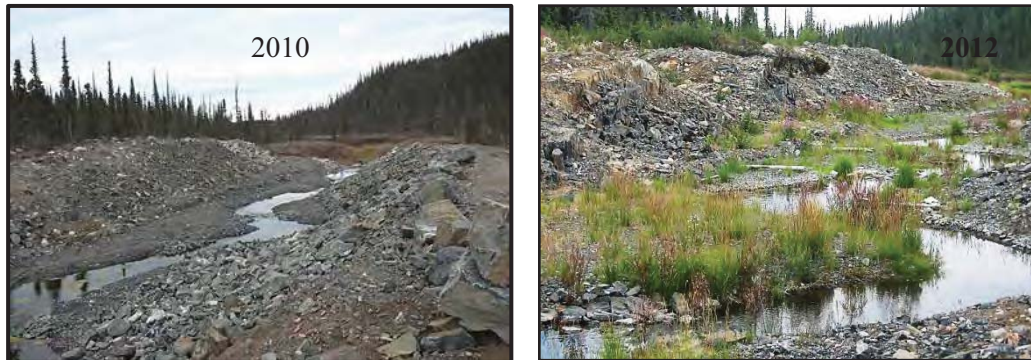
Figure 4. Dam 2 channel before (2010) and after (2012) revegetation efforts.

In 2010, construction of the Dam 2 drainage was finished and water flowed in the channel. Revegetation included planting 40 sedge plugs in the channel and sowing native grass and alder seed along the channel terraces and upland banks (Figure 4).
