**EROSION MONITORING  
ON  
MOUNTAIN FOOTHILLS  
WASTE DUMPS**

**Presented at the  
CLRA Conference, Hinton, Alberta  
"Reclamation in the Eastern Slopes of Alberta"**

**R.G. Chopiuk, P.Eng., Manager, Mining Division  
S.E. Thornton, P. Eng., Project Engineer**

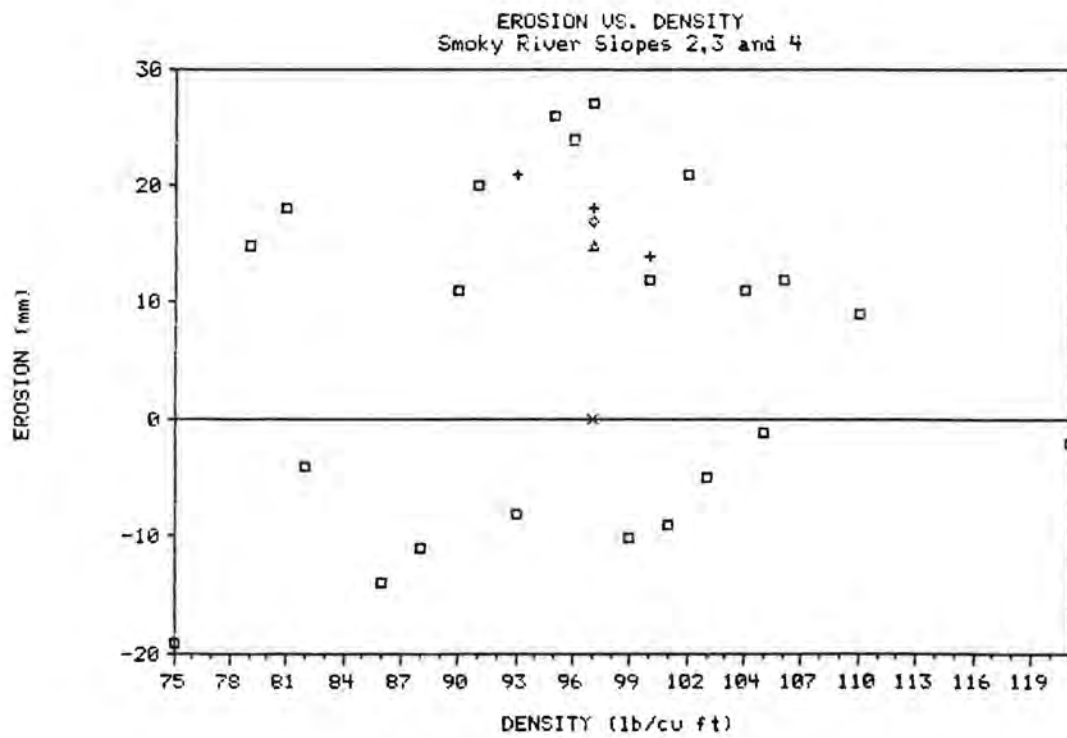
Figure 10

Laboratory analyses of the samples collected from the slopes at Smoky River were not as helpful as was initially hoped. There appears to be some relationship between density and erosion for slope 4 as shown in Figure 9, where erosion decreases with an increase in density of the soil. When the analysis from slopes 2 and 3 are included, no well defined relationship is apparent, as portrayed in Figure 10.
