CASE STUDY OF THE REHABILITATION OF THE HISTORICAL CONIAGAS NO. 4 SHAFT IN COBALT, ONTARIO

41st CLRA National Annual General Meeting and Conference

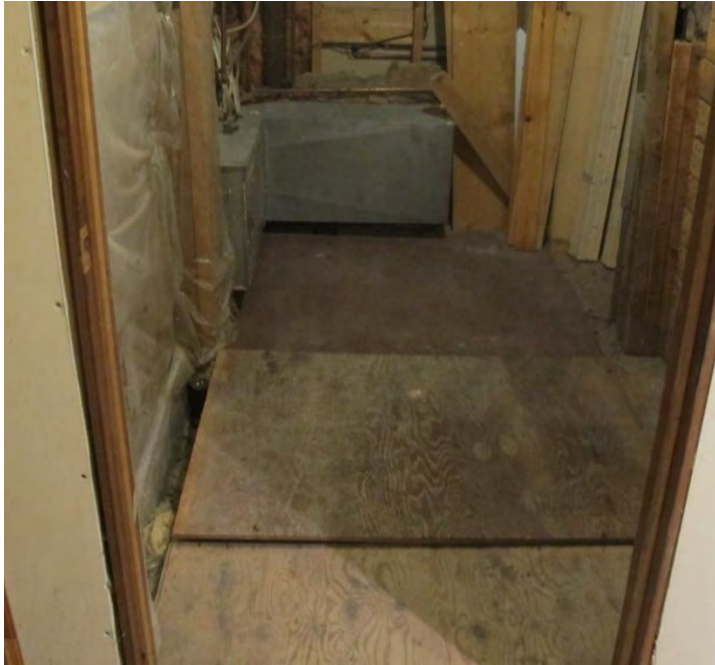
Golder Associates Ltd. (Golder) completed a preliminary investigation with Agnico Eagle Mines Ltd (Agnico Eagle) that consisted of reviewing historical records, and completing a site visit to locate and record the status of the shaft before a detailed investigation was completed. Historical records from previous investigations suggest that the cap was constructed of 18" thick concrete reinforced with 16 lb mine rail and 6-inch square wire mesh, and also indicated that an access port in the top of the cap was left open and covered with planks. The shaft cap was located under the ground level floor of the building inside a storage closet (Figure 5).

Figure 5: Location of shaft cap access port under plywood floor

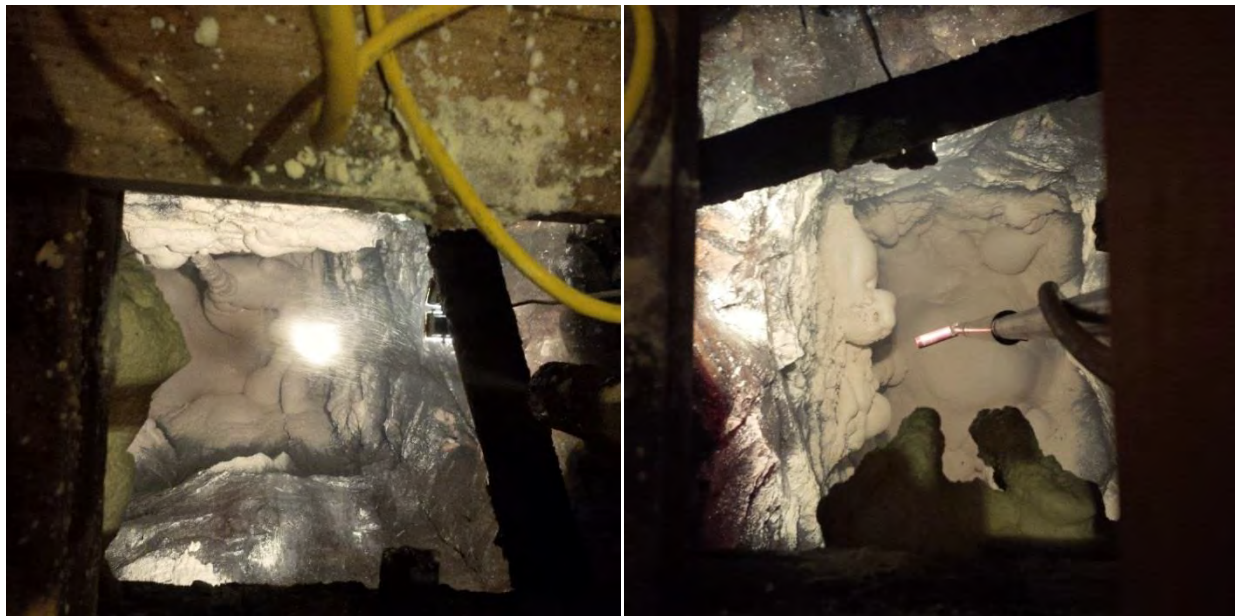
Figure 8: Application of Polyurethane Foam Plug and Cavity Monitoring Survey Using the C-ALS System

The first phase of backfilling consisted of spraying an expanding polyurethane foam on the timber obstruction in the shaft, using the obstruction as a form. The objective of phase one was to build a foam plug in the shaft which would act as a form for the higher strength concrete plug. The foam plug was constructed using three sets of 55 gallon drums of Part A and Part B of 2 lb. medium density closed cell polyurethane foam, which is typically applied as residential insulation. The foam was sprayed from surface through the opening in the shaft using a nozzle that would ensure that the liquid stream could reach the timber obstruction and not hit the walls of the shaft. The foam was applied evenly across obstruction and around the edges of the shaft walls to minimize the risk of concrete leaking around the foam during the next phase. A CMS was completed after the foam had set, and indicated that a foam plug thickness of 7 m had been achieved. This was approximately twice as thick as originally anticipated, likely due to the expansion rate being under estimated during the planning stage. The CMS showed that the surface profile of the foam was not flat (i.e., it was mounded in the center of the shaft). Figure 8 shows the application of the spray foam and the subsequent CMS. The foam was allowed to set for 24 hours before commencing Phase 2.

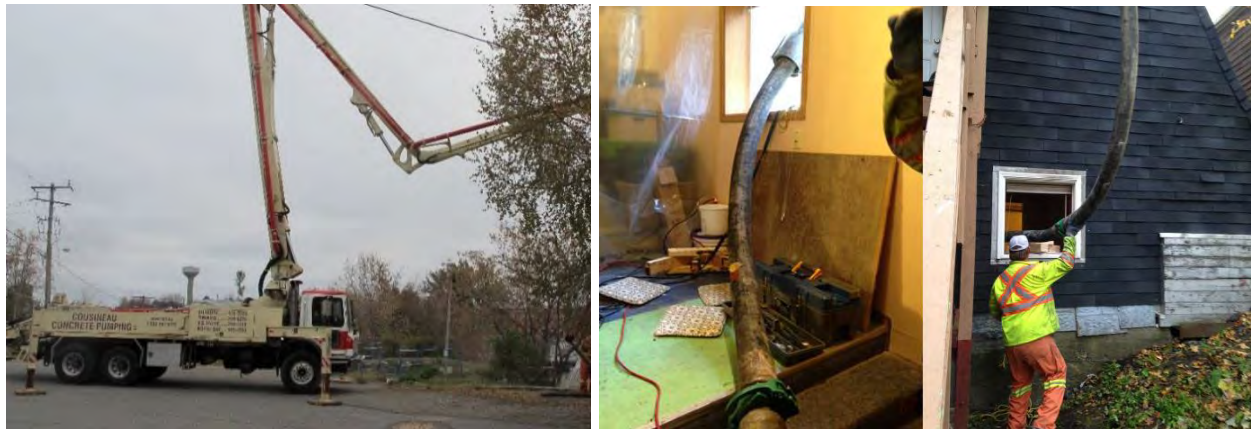
Figure 9: Concrete pump truck and slick line used to pump concrete into shaft void

A total of 12.5 m³ of 35 MPa concrete was pumped into the shaft void using a positive displacement pump with a slick line through a window in the building into the shaft, as shown on Figure 9. A CMS was completed after the Phase 2 concrete was pumped into the shaft and indicated that high strength plug was approximately 1 m higher than the surface of the foam plug after Phase 1. Based on the shaft area from the CMS and the volume of concrete delivered, it was estimated that the foam had compressed 0.5 m, resulting in a concrete plug that was 1.5 m thick, as planned. It was anticipated that compression of the foam plug would occur between 20% and 30% based on some rudimentary lab testing of foam cores completed at another project location leading up to this work. Observations of the concrete pour showed no evidence of the concrete leaking through the foam plug.

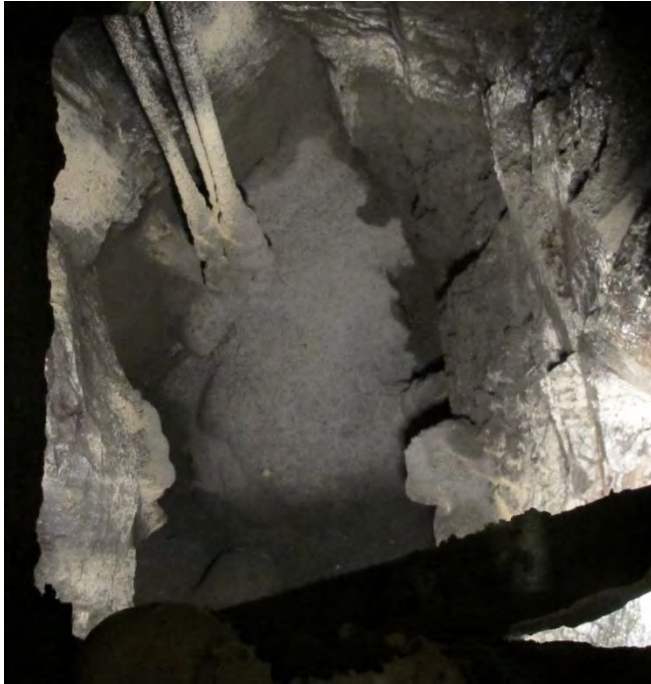
Figure 10: Specified 35 MPa fibre reinforced concrete for initial plug

A sample cylinder of the high strength plug was broken after 6 days curing time in order to confirm that the concrete had achieved the strength necessary to support the second concrete pour. The uniaxial compressive strength test indicated that the initial concrete pour had reached a strength of 22.7 MPa, which represented a FOS of 4.9 based on the Mitchell equations when considering the load of the second pour. Figure 10 shows the shaft after placement of the high strength concrete plug.

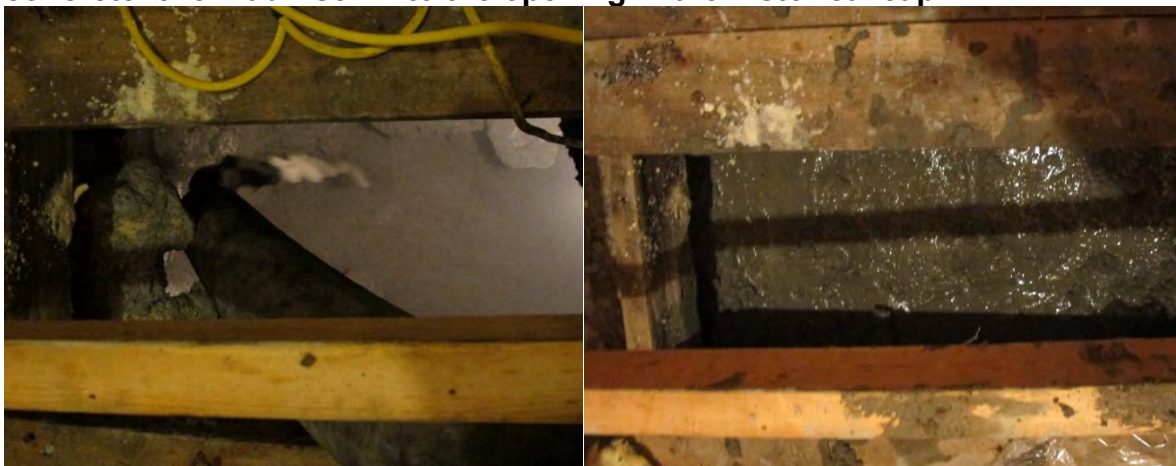
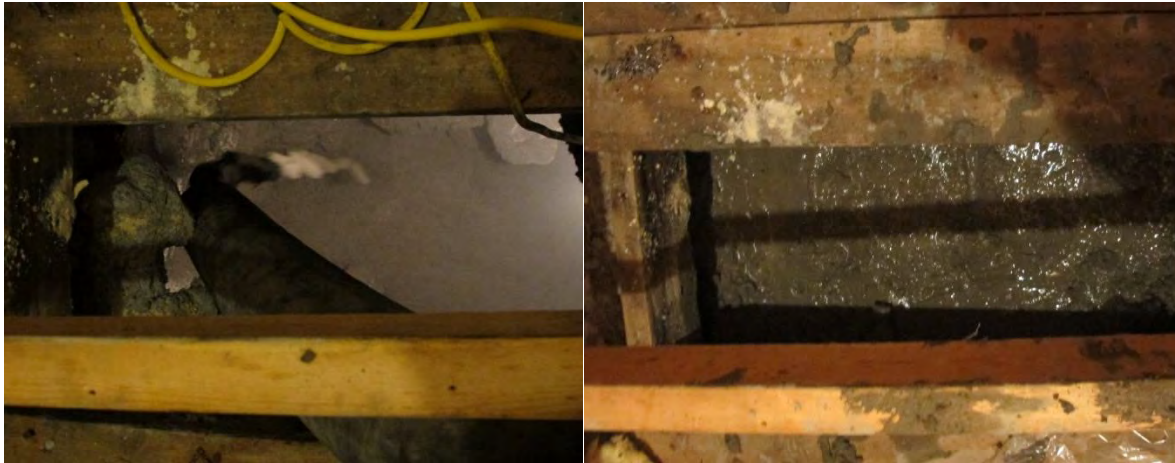
Figure 11 shows the delivery of the final concrete plug and the location of the plug surface inside the historical cap.

Figure 11: Pumping specified 25 MPa concrete for final plug

The objective of Phase 3 was to fill the remaining void volume and have the final plug be in contact with the historical cap. The minimum concrete strength planned for this phase in the design was 5 MPa; however, 25 MPa concrete was ordered from the supplier to maintain pumping ability through, also considering the differential cost was minimal. Approximately 104 m³ of 25 MPa strength concrete was pumped into the shaft void. Pumping was ceased when the concrete level had risen into the opening in the historical cap.
