COST EFFECTIVE PLANS FOR SUCCESSFUL MINE CLOSURE – RECENT CASE STUDIES

Marc S. Theisen

41st CLRA National Annual General Meeting and Conference

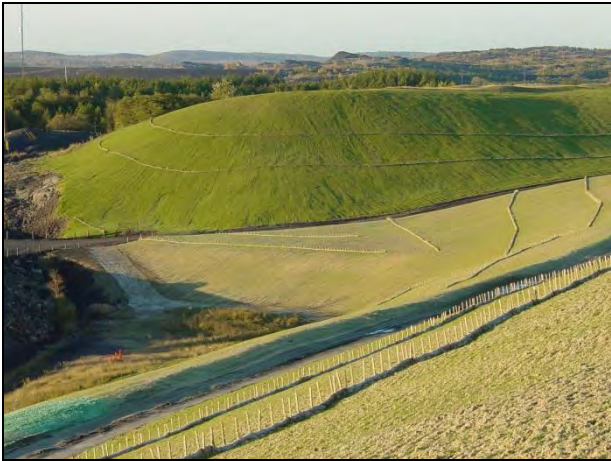
Figure 1 - Initial installation – Oct 2007

Despite the fall seeding, germination occurred quickly and vegetation was growing in the areas first treated prior to the onset of winter and a snow cover approaching 1 m in depth that persisted throughout the winter season. The following spring vegetation emergence continued and the site achieved exceptional cover with the combination of prescribed soil amendments, seed mix and flexible growth medium.

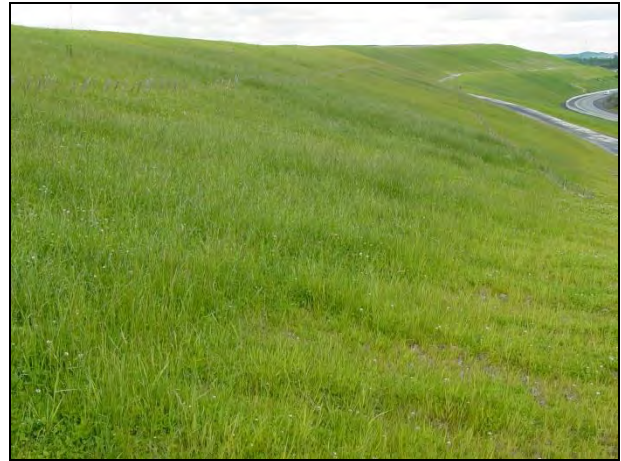
Figure 2 - Successful vegetation – June 2008

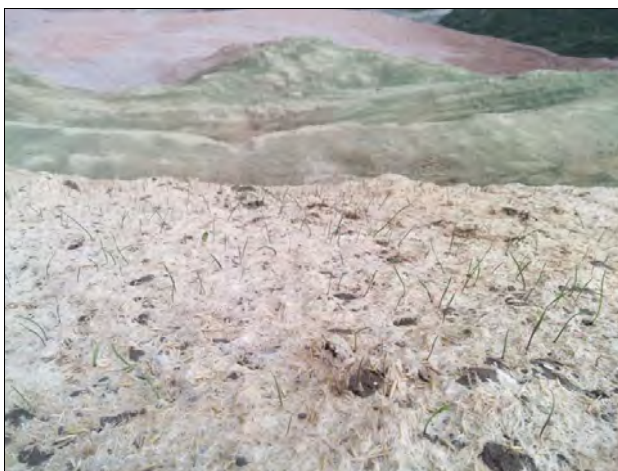
Figure 5 - Growth after 10 days

Planting experiments were conducted with guidance from Qinghai Provincial University to determine locally available plant species adapted to the harsh site conditions. Selected species included *Elymus nutans*, *Festuca arundinacea*, *Calendula officinalis* and *Hypoxis sp.* at a rate of 35 kg/ha. Installation of the reinforced hydroseeding method occurred in July and August of 2014. The irrigation system was used when necessary and a reasonable cover of vegetation was established going into the winter season.

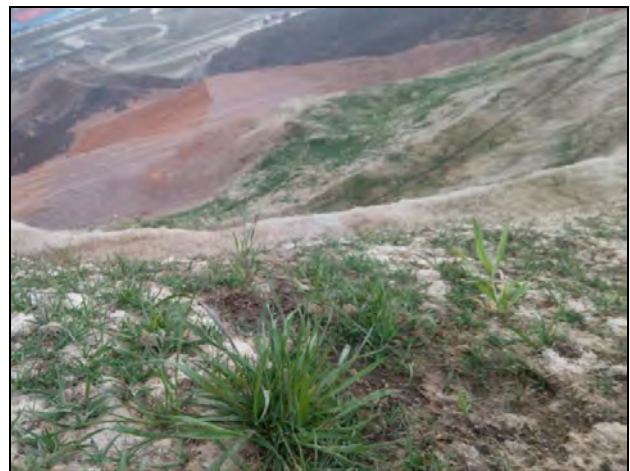
Figure 6 - Growth after 60 days

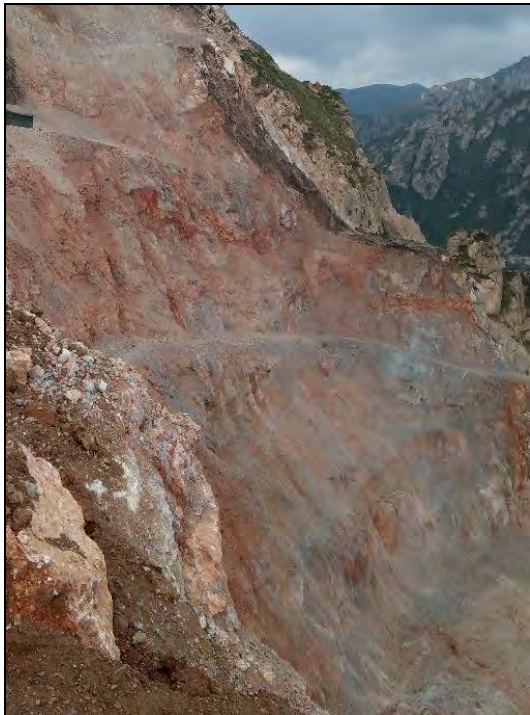
Figure 7 - Prior to installation in 2014

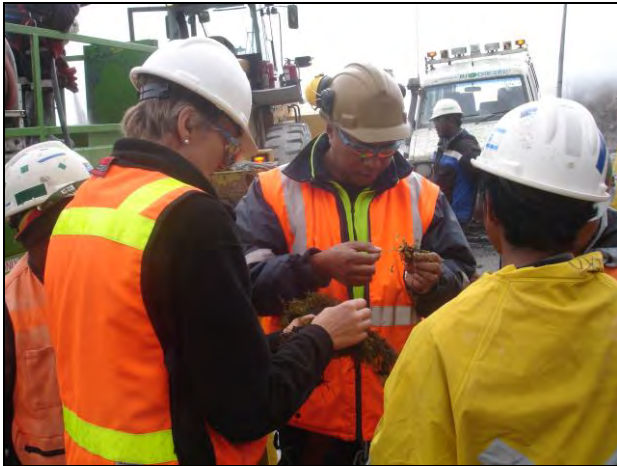
Figure 9 – Hand collected moss sprigs

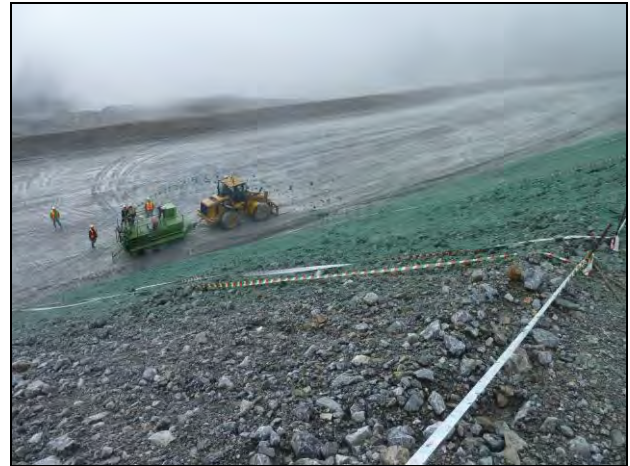
Figure 10 – Application of slurry to top of slope

The application rate of the FGM was held constant at a rate of 3,638 kg/ha – which was slightly less than the recommended application rate of 3,900 kg/ha for the 2H:1V slopes used for the test plots. This was due to a limited supply of the material on this remote site. The rate of hand collected native moss sprigs were also held constant at 1,333 kg/ha per plot. On 10 and 11 April 2013, all materials were hydraulically-applied in one step using a 4,169 L capacity hydromulcher in predominantly wet, cool conditions.

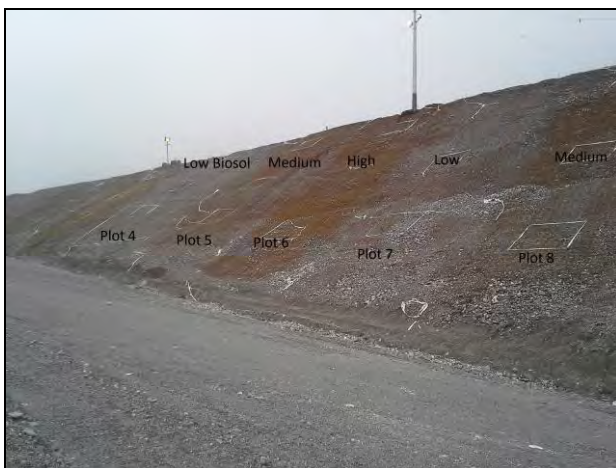
Figure 11 – Plots 1-7 – varying amendment rates

Results after two years of monitoring were predictable given the sterile overburden characteristics combined with the challenging site conditions. Germination of the *D. caespitosa* was spotty and the seedlings demonstrated gradual die off from lack of organic matter, soil structure, microbial activity and available nutrients to sustain growth of the grasses. However, the moss sprigs performed reasonably well and have begun to colonize the exposed rock surfaces. There is a distinct correlation to amounts of organic matter and biostimulants applied to the test plots. Those plots with higher amounts of organic matter and biostimulants showed greater establishment and coverage of the moss as shown in Figures 11 and 12.

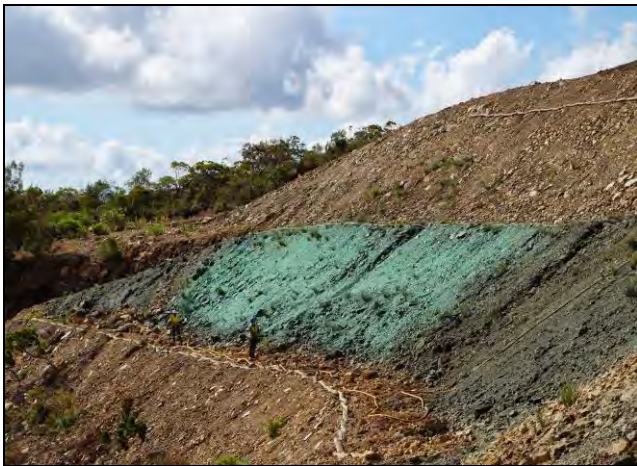
Figure 13 - Second application over compost layer

Installations were conducted in July/August of 2012 employing the two-step methodology as described above. Despite very heavy rains soon after installation establishment of the grasses was very good with consistent ground coverage as shown in Figures 13 and 14.

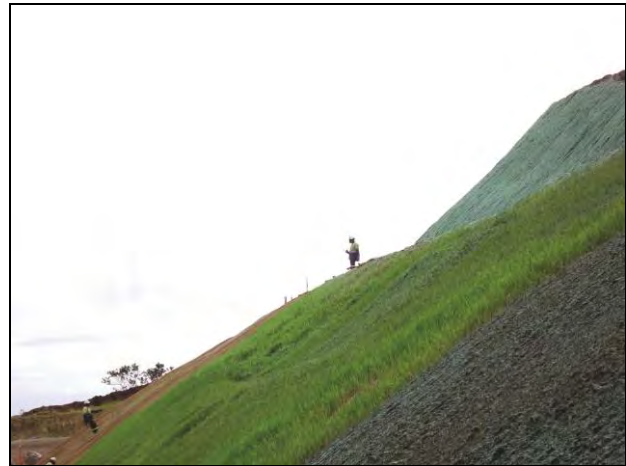
Figure 14 - Establishment of grasses in first year

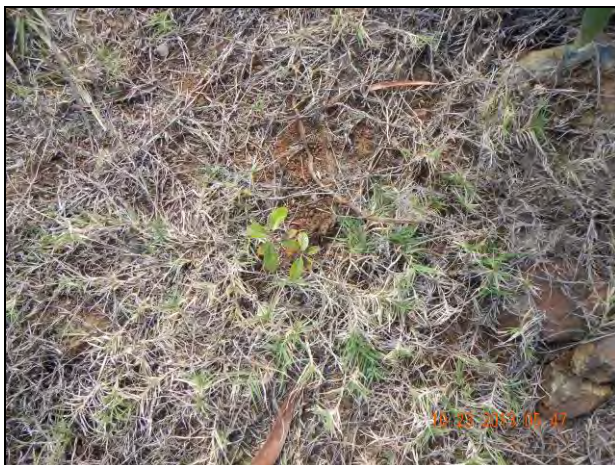
Figure 15 - Indigenous shrub seedling growth
